# Tooele City

## 2022

# Sign/Sidewalk Assessment and Budget Recommendations

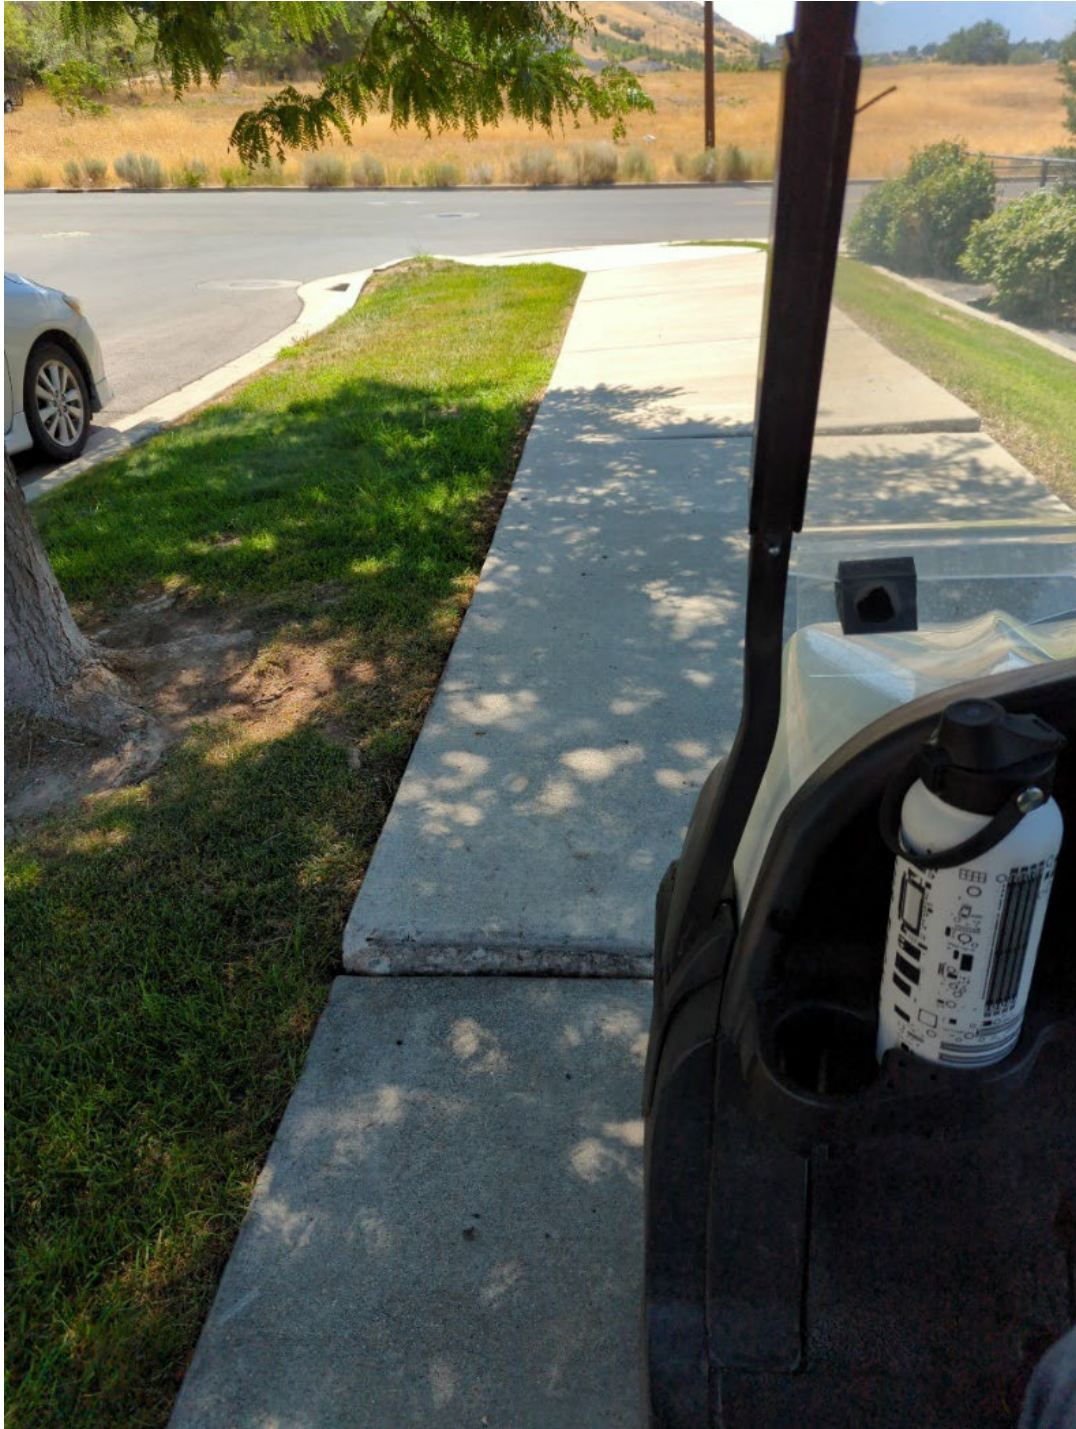
**Vertical Separation** is rated at ¼ inch, ½ inch, 1 inch, 2 inches, and above 2 inches. ADA considers anything over ¼ inch as a trip hazard. The shorter trip hazards can be fixed by grinding down the raised sidewalk slab until flush with the lower sidewalk slab. These distresses are often caused by tree roots and may require removal of the roots to stop the damage from resurfacing.

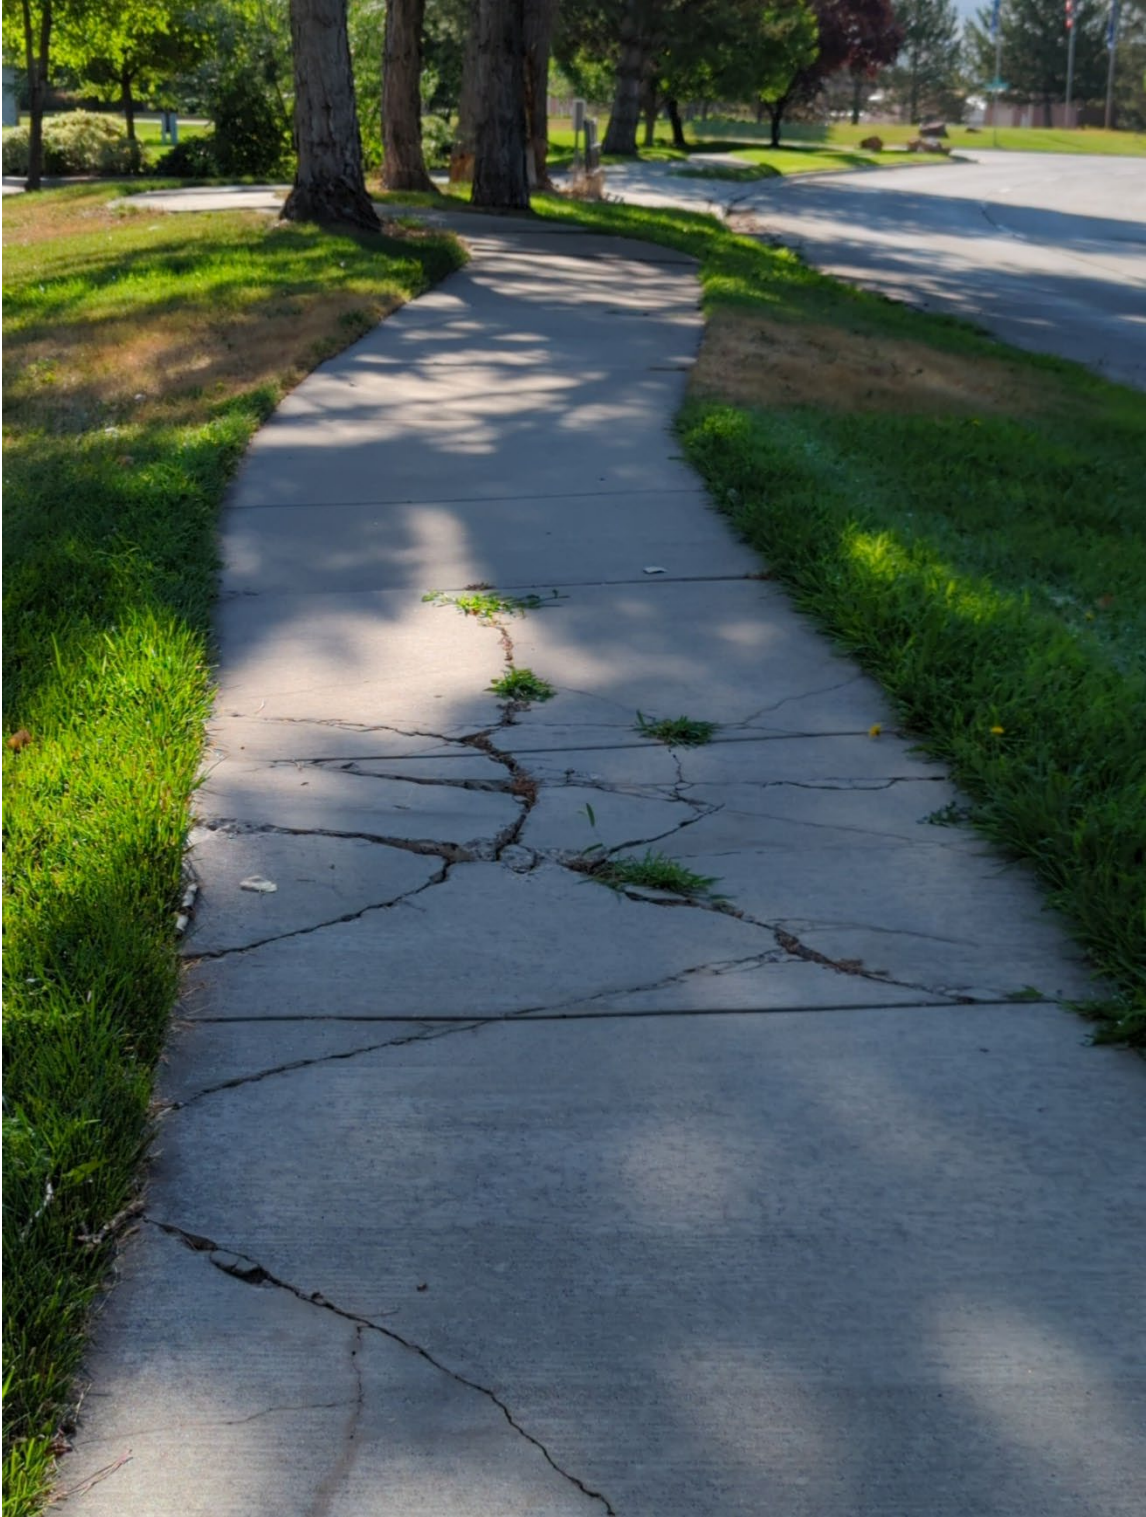
**Multiple Cracks** are rated on the presence of sprawling cracks on a slab. This distress can be fixed by replacing the damaged slab.

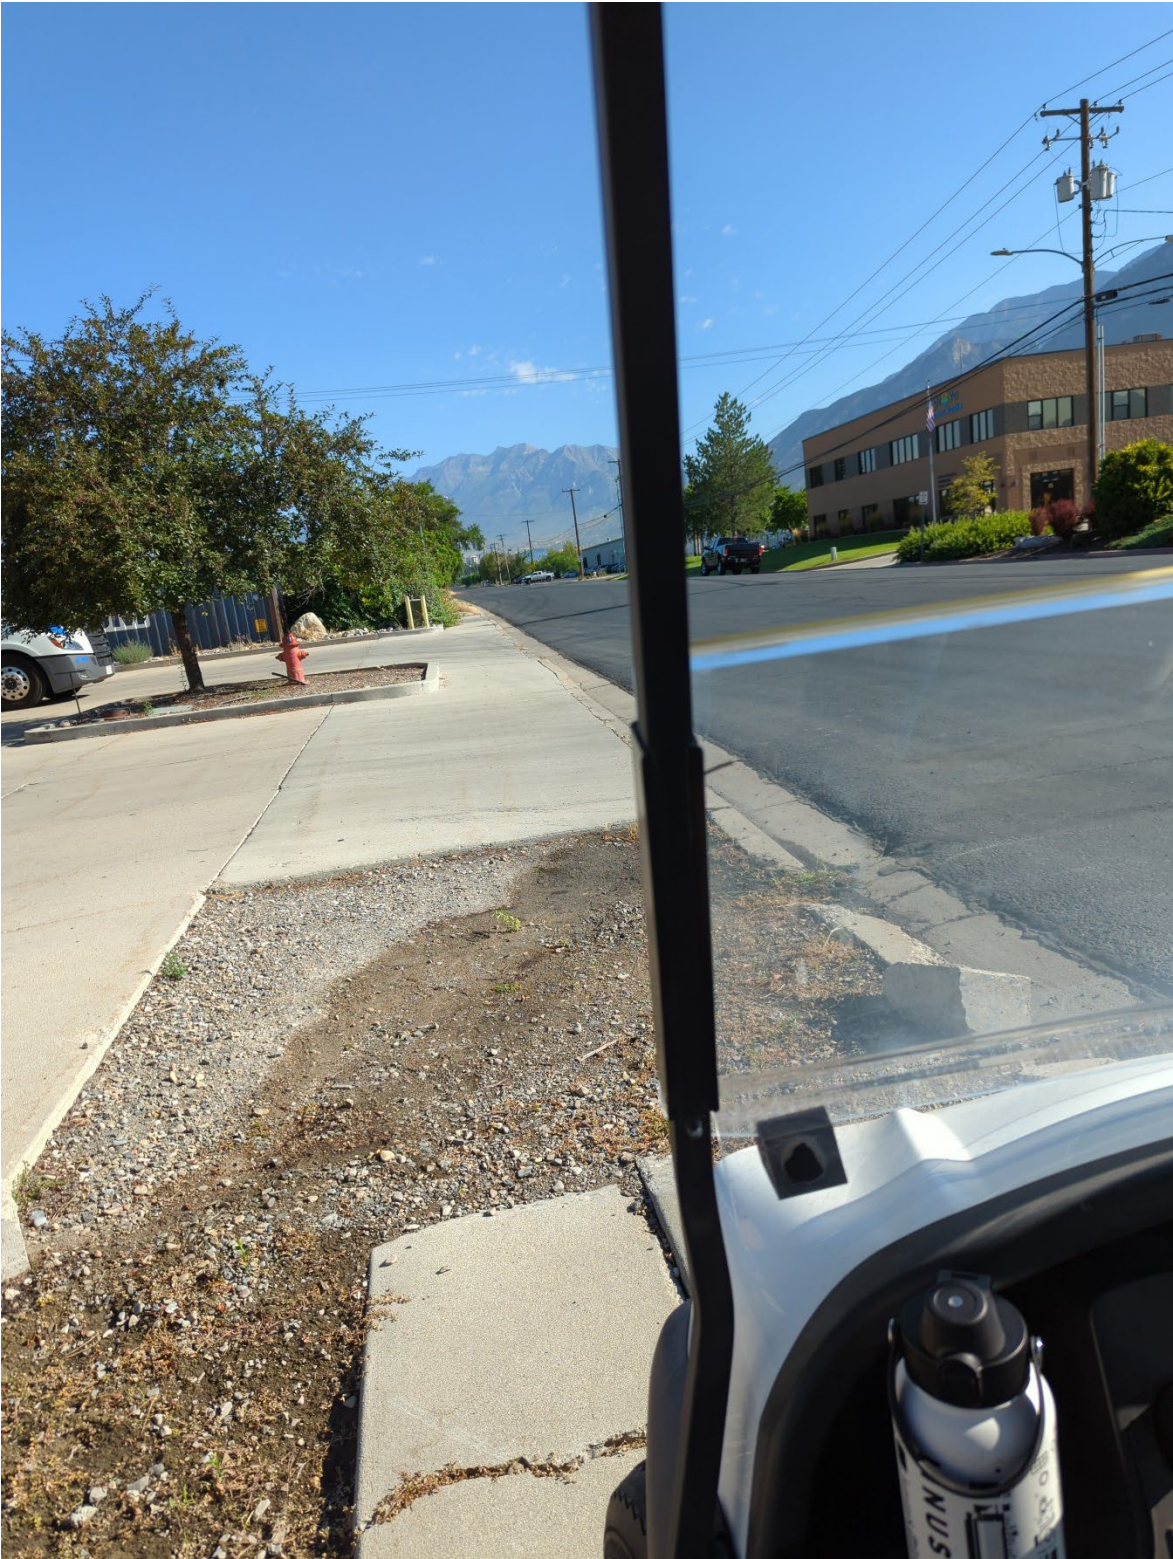
Missing panels are fixed by constructing a new sidewalk slab.

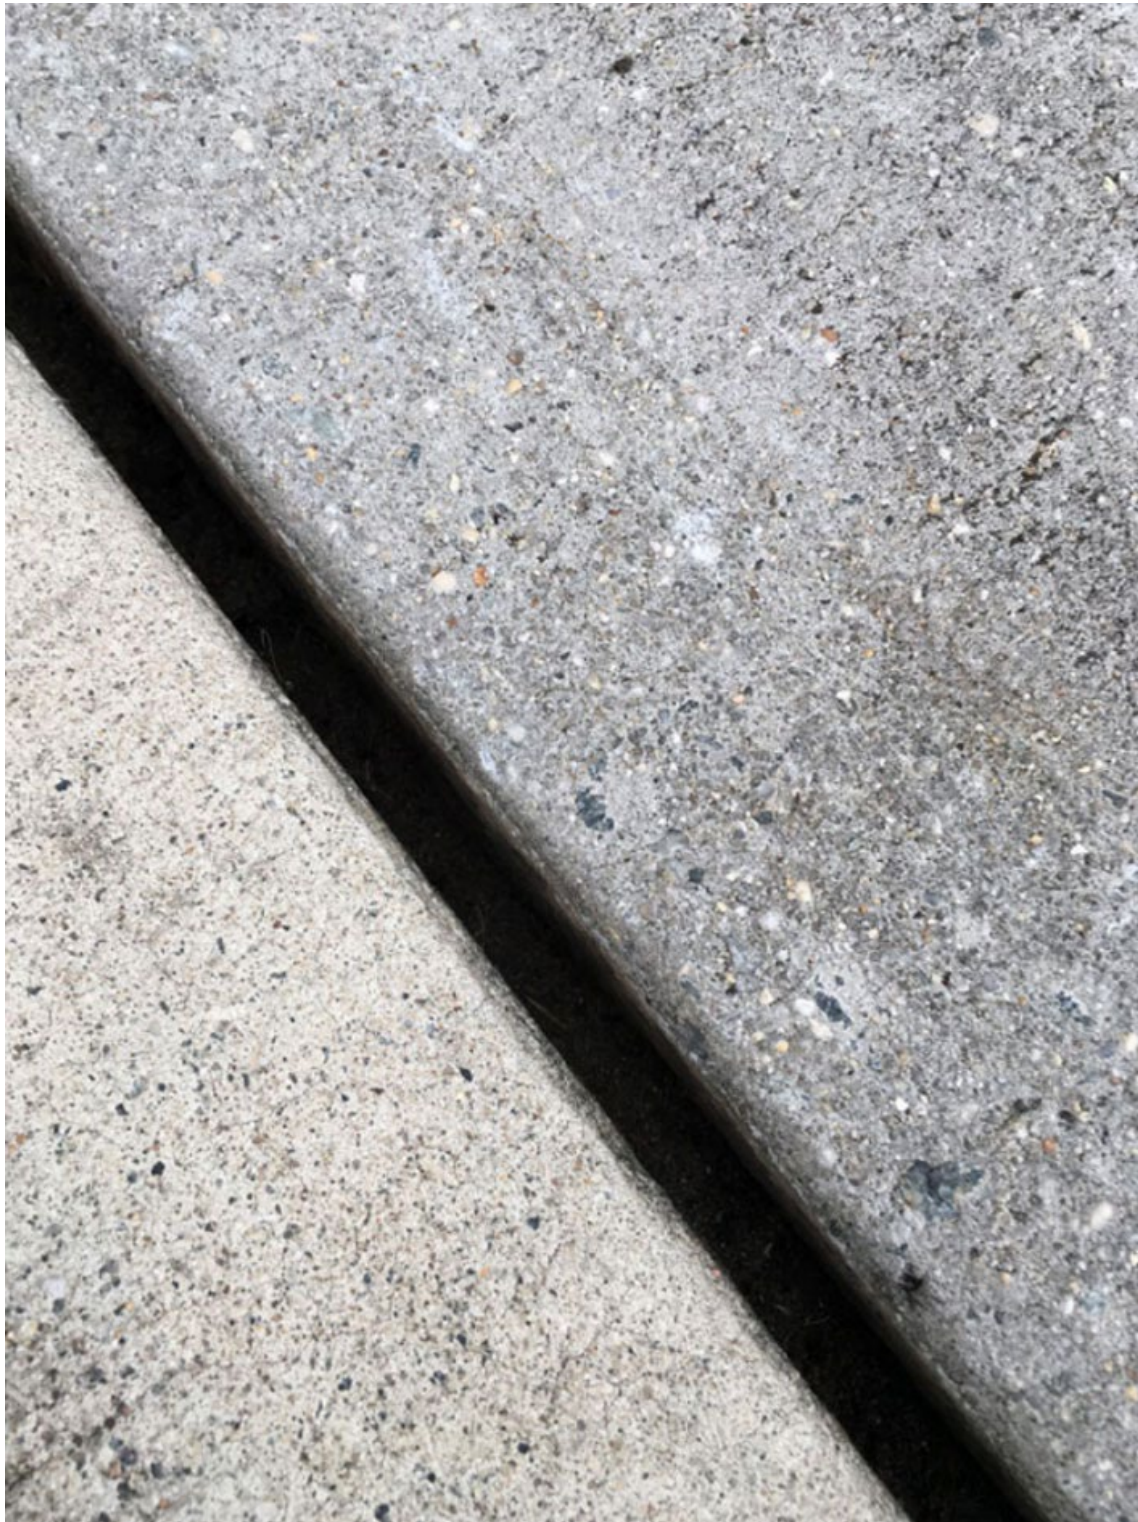
**Horizontal separation** is rated at greater than 1 inch. Horizontal separation above 1 inch can be corrected with sidewalk calking to fill the gap between sidewalk slabs.

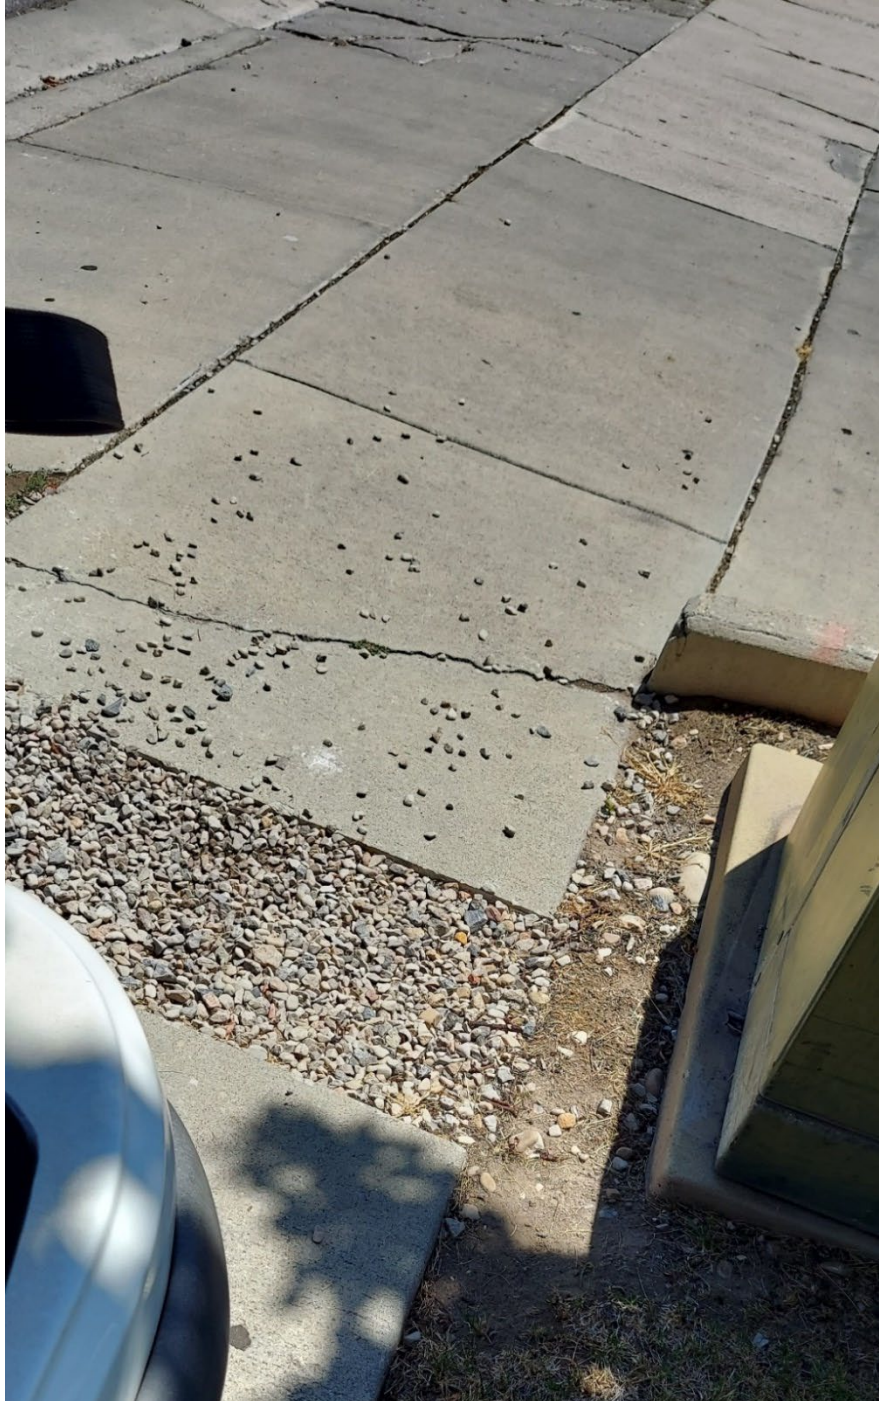
**Missing Pieces/holes** are given fair or poor ratings. A fair rating means the holes or missing piece would require up to half of the slab to be repaired. A poor rating means the holes or missing pieces are significant enough to require slab replacement.

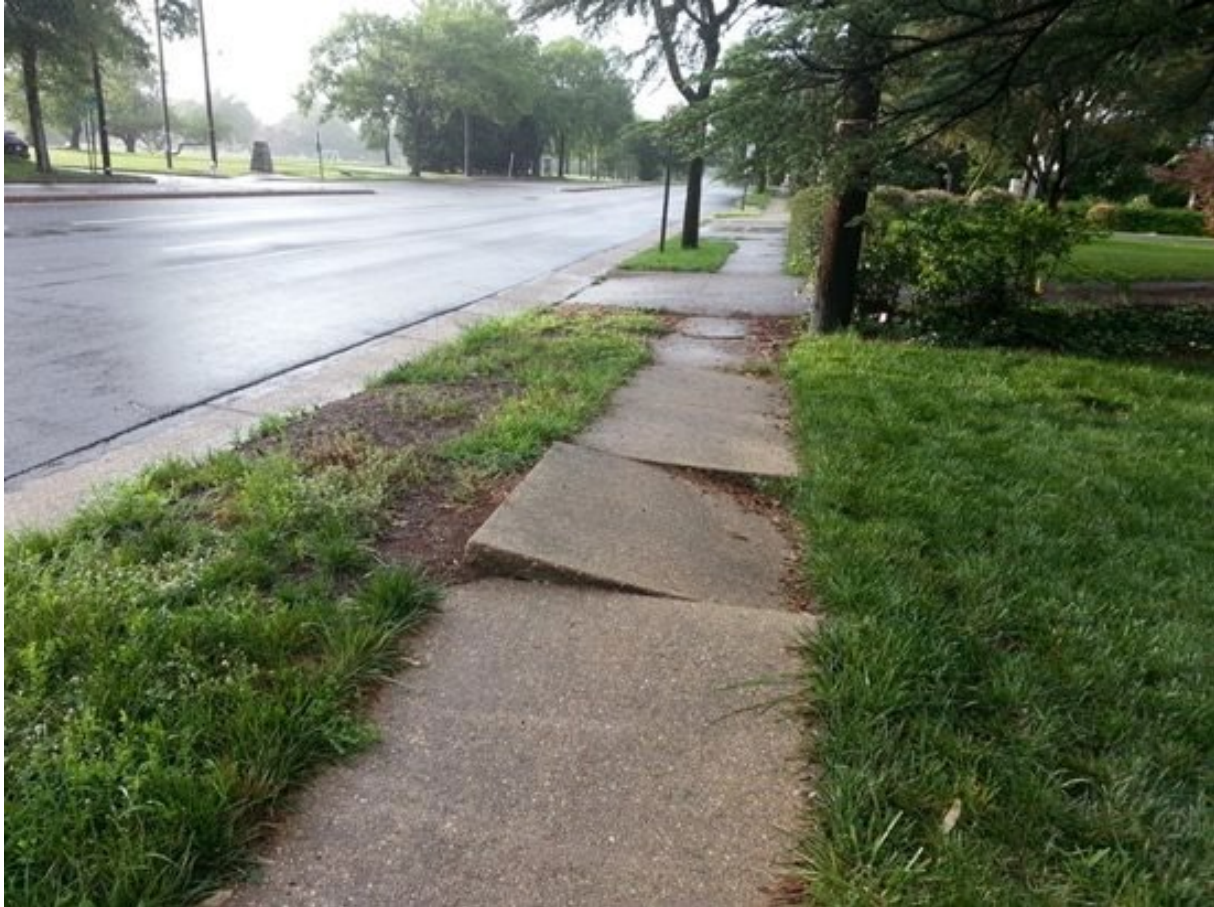
**Sag** is rated with fair or poor. A fair rating means the slab is offset by at least 1 inch. A poor rating means the slab is offset by greater than 1 inch. This distress might be fixed by mud jacking the sidewalk slab up to be level with the adjacent sidewalk slabs. Larger offsets, often caused by roots may require replacement of the slab.

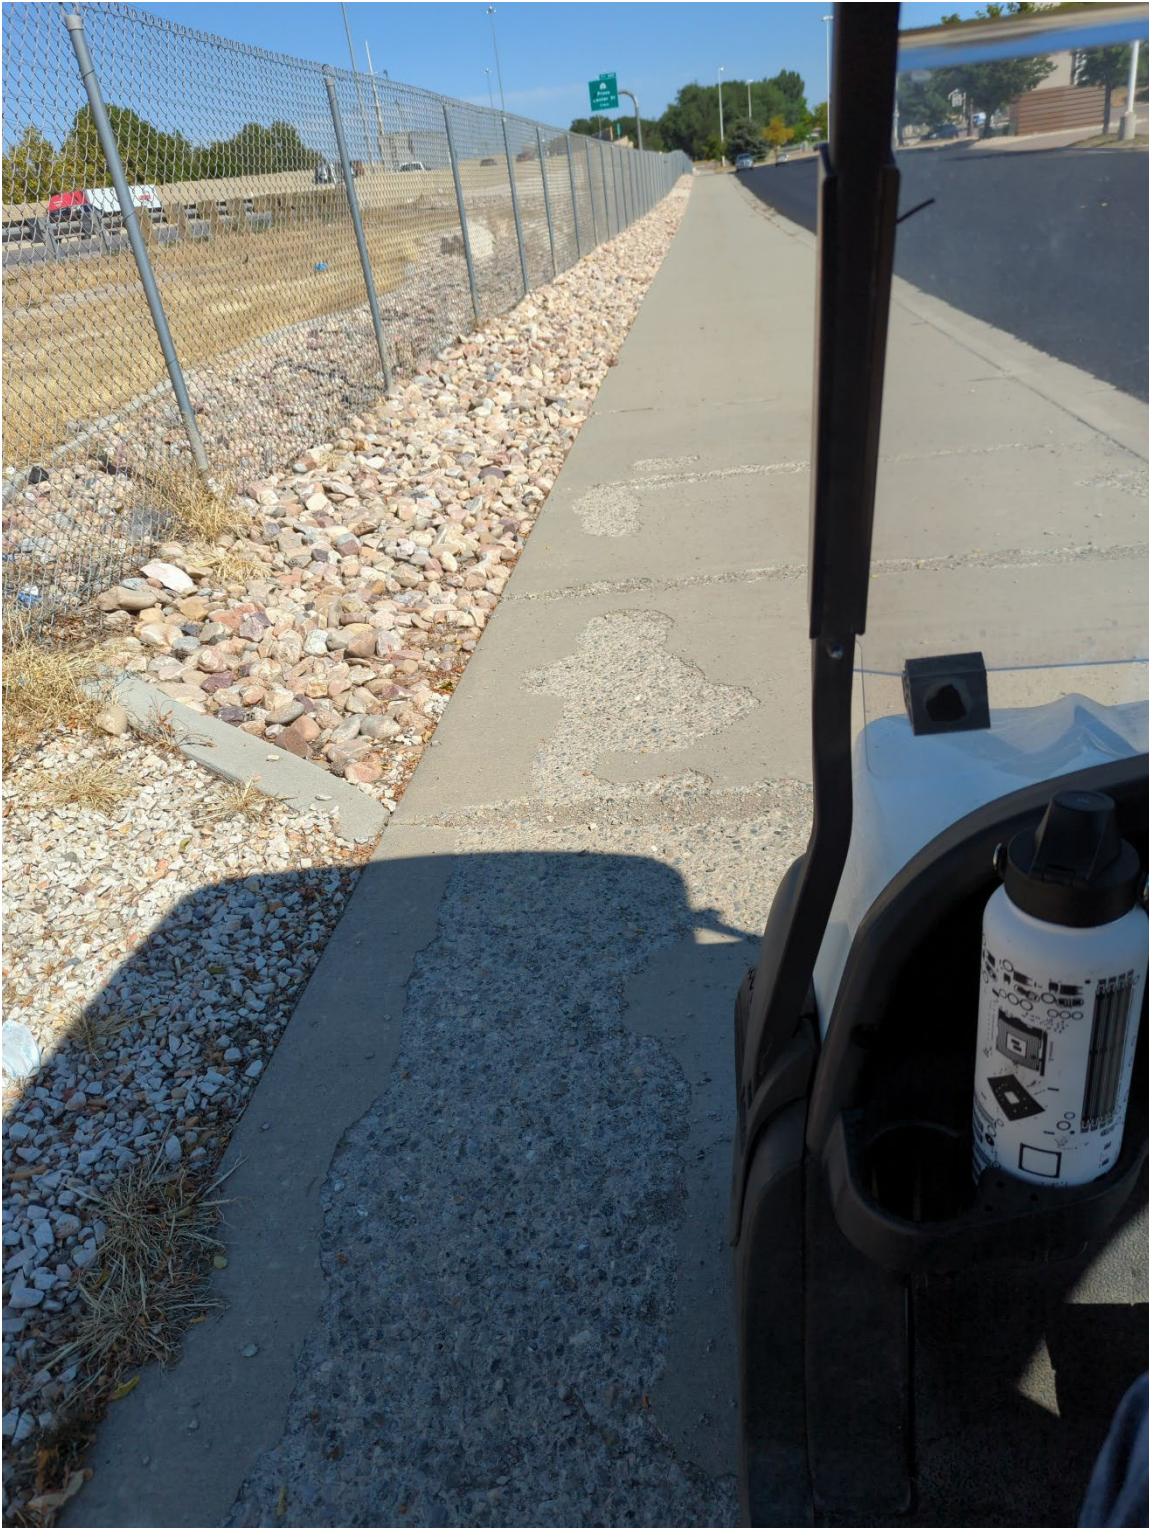
**Spalling** was rated as fair or poor. A fair rating means the slab is less than half covered. A poor rating means the slab is greater than half covered. This distress can be fixed with a resurface of the sidewalk slab or replacing the concrete slab depending upon the damage severity.

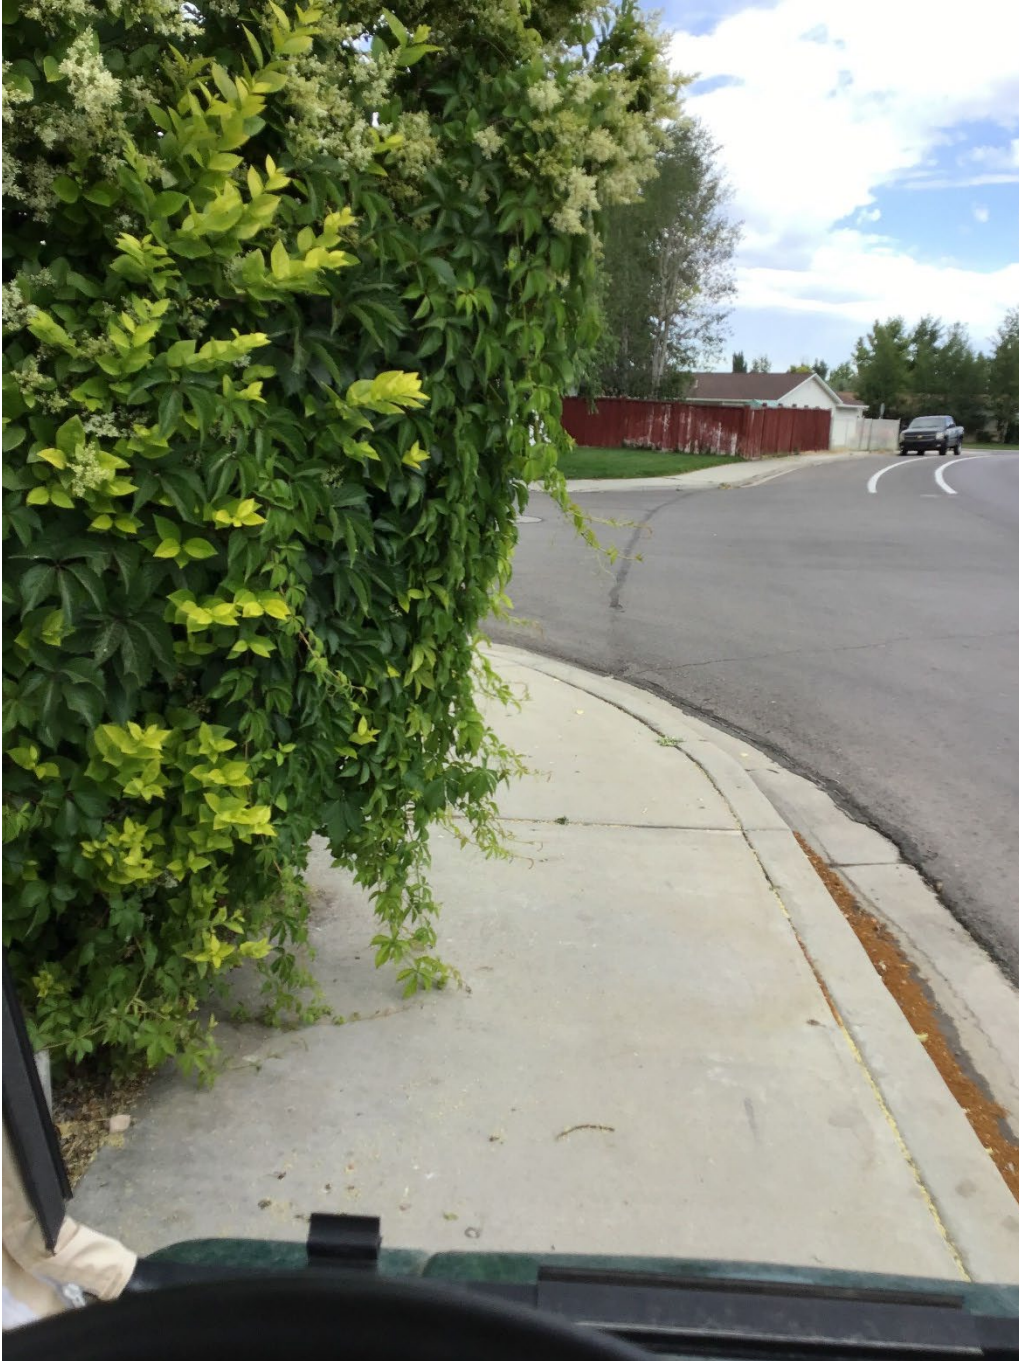
**Trees/bushes** need to be trimmed back in both width and height to allow free passage of pedestrians.

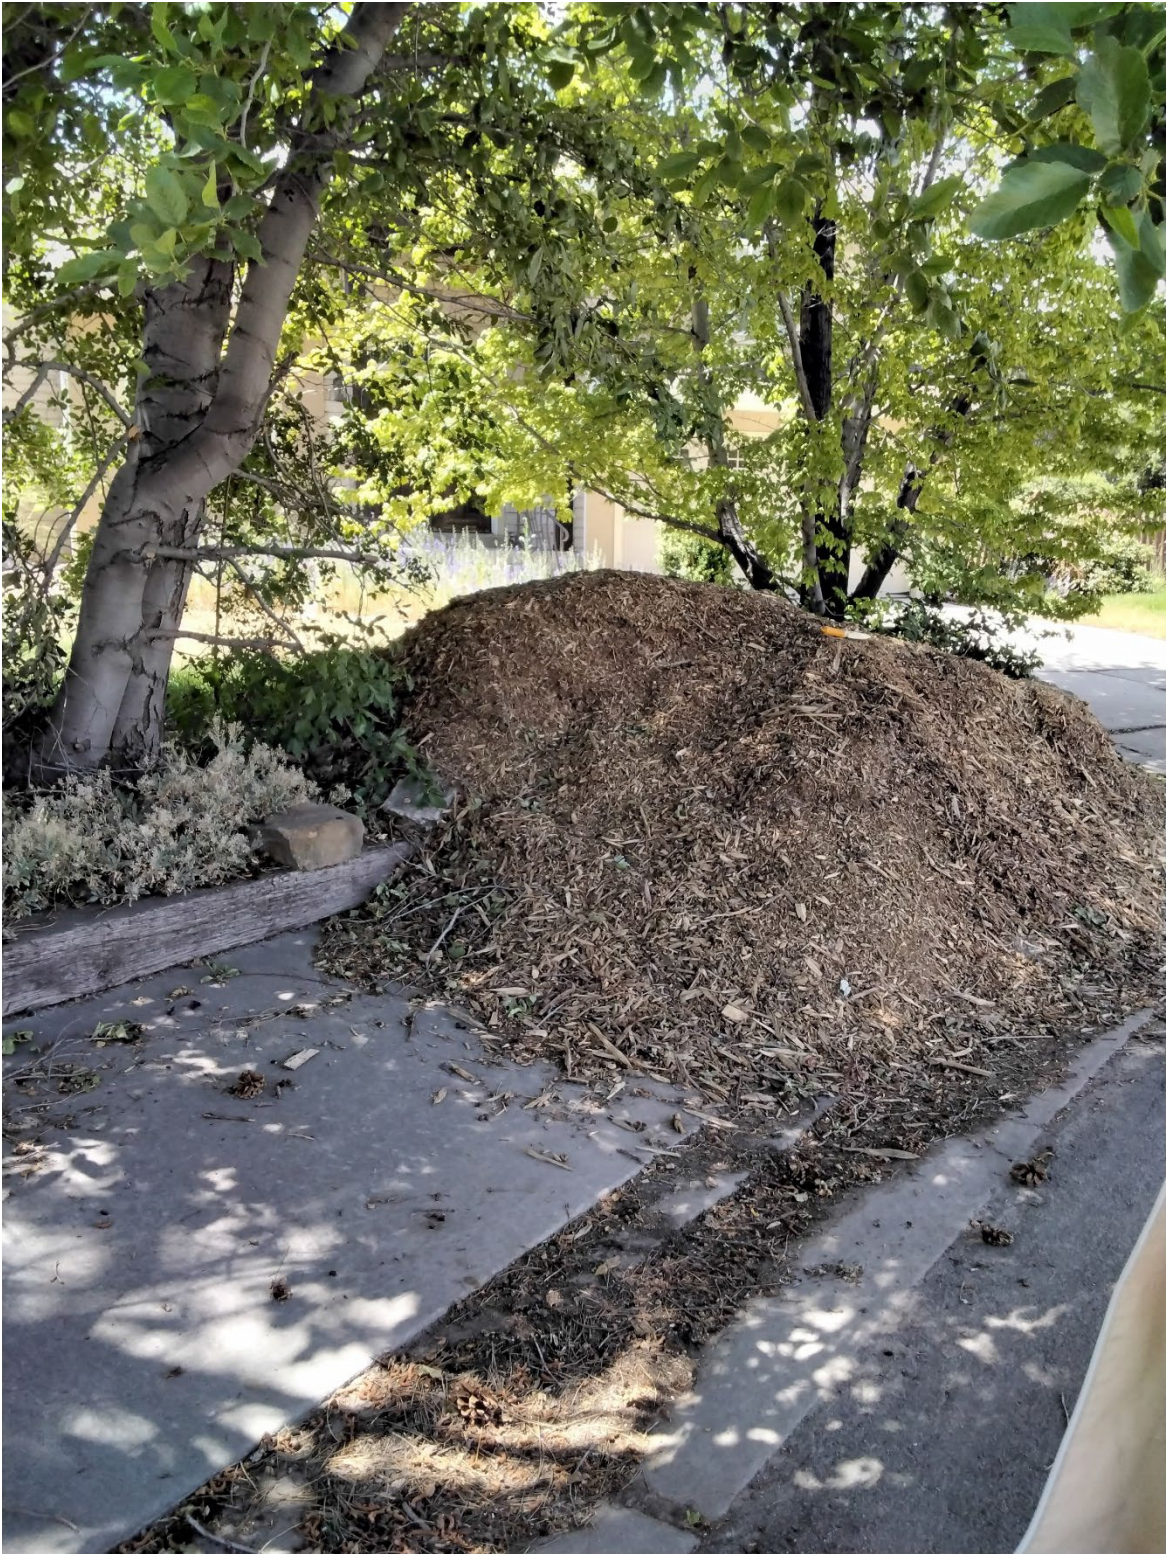
**Rocks/Landscaping** could require a homeowner or city to alter the edges of the property to allow free and safe passage of pedestrians over the sidewalk.

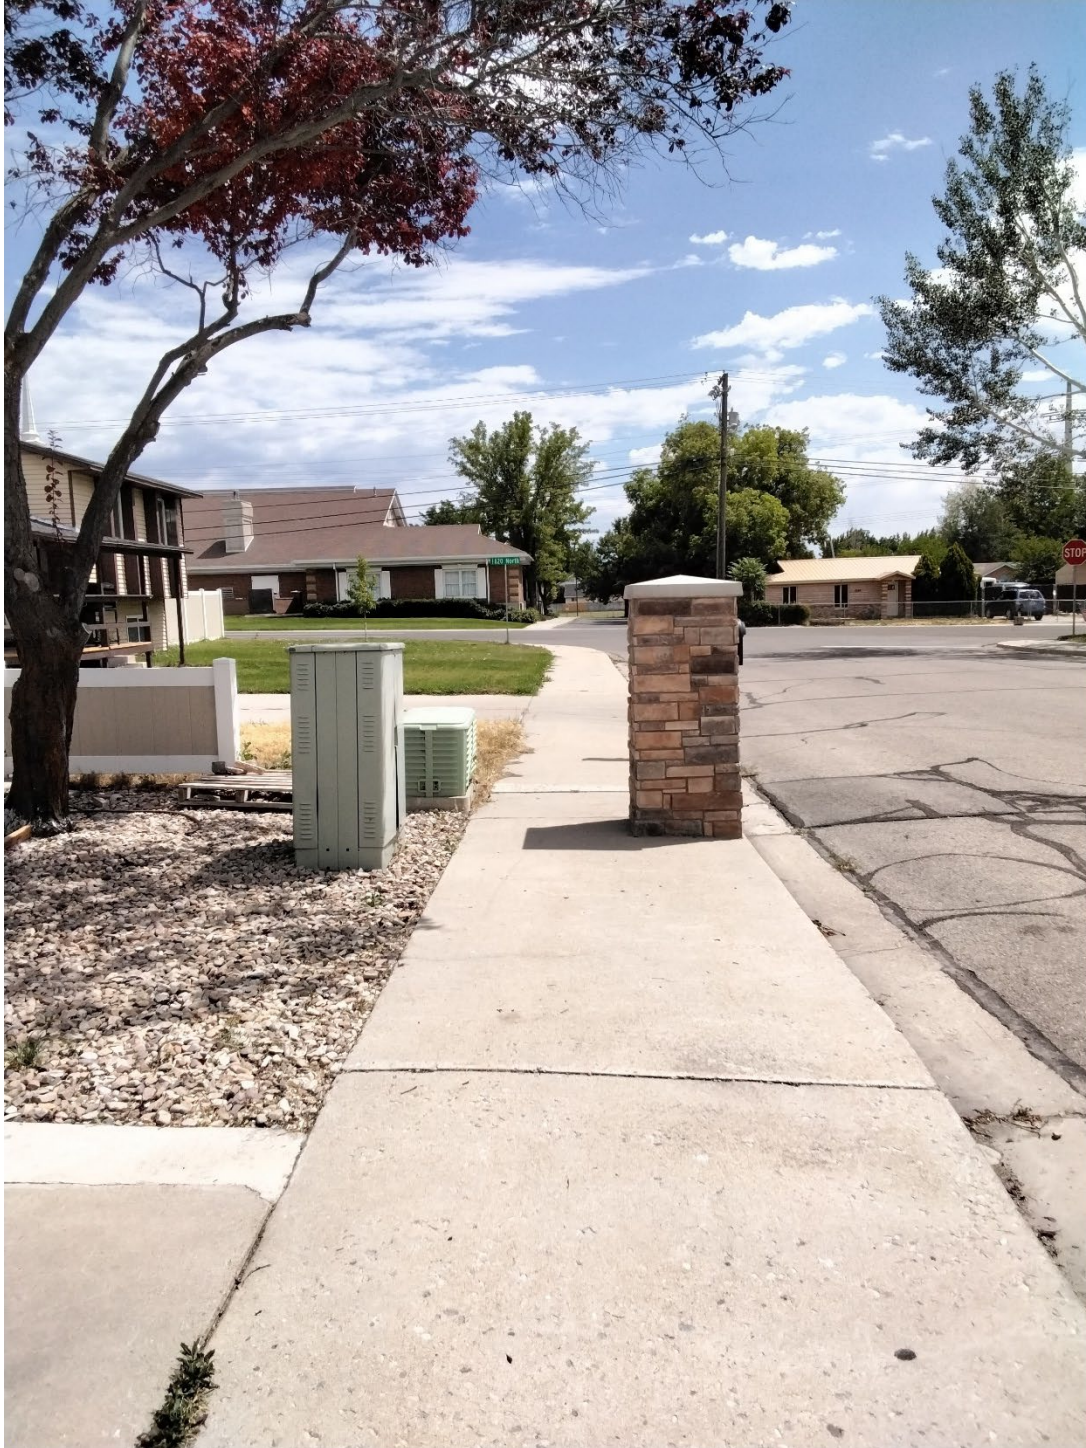
**Mailboxes** have multiple issues to fix. The first issue is when a sidewalk segment has no grass strip between it and the roadway. This causes homeowners to place their mailbox on the edge of the sidewalk causing an obstruction. The second issue is mailbox type and size. Many decorative mailboxes require more space and can obstruct the sidewalk for pedestrians.

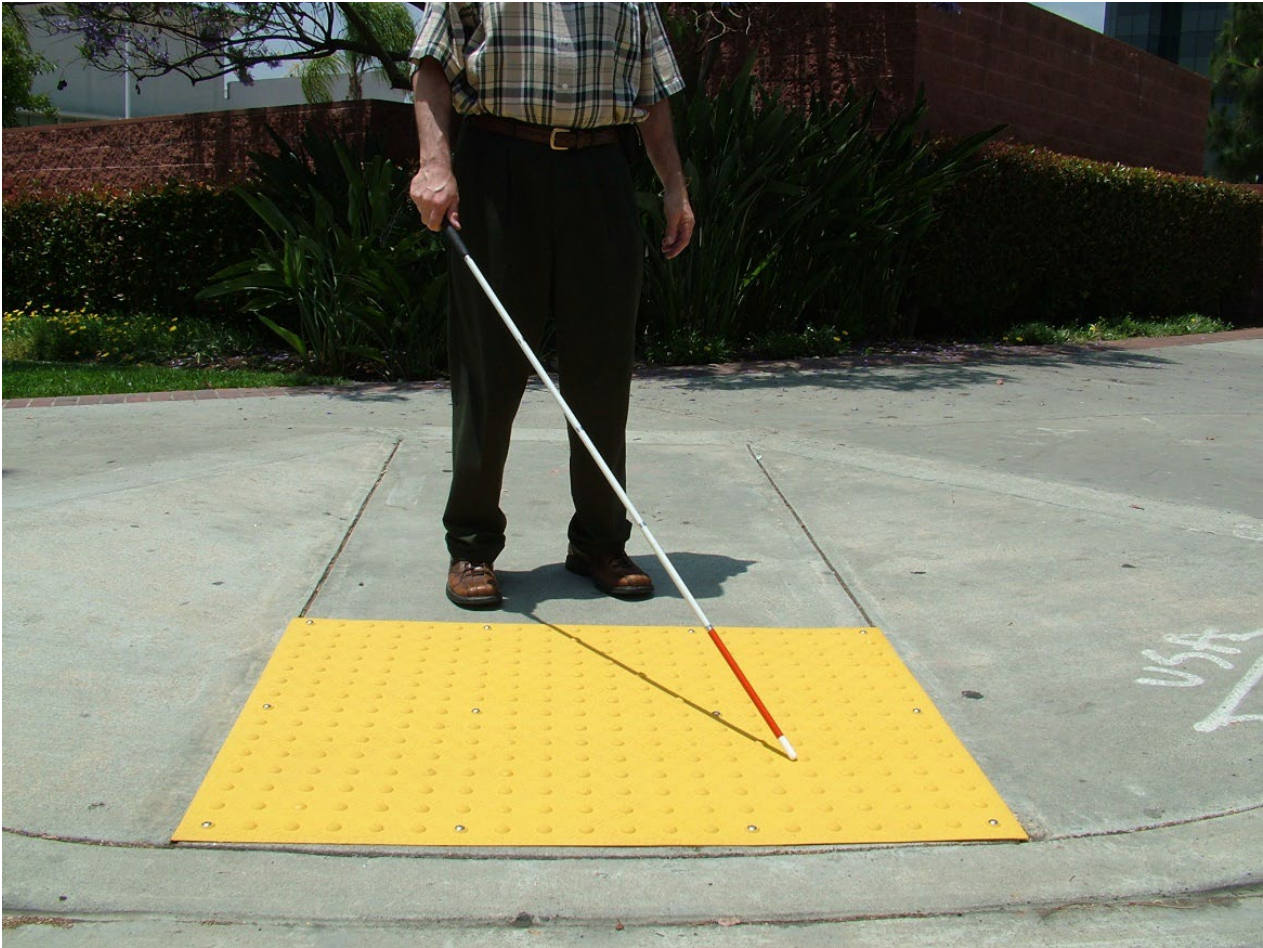
**Ramp with detectable warning surface** requires no reconstruction but may require maintenance depending upon the quality of the ramp or if the ramp isn't following other ADA standards.

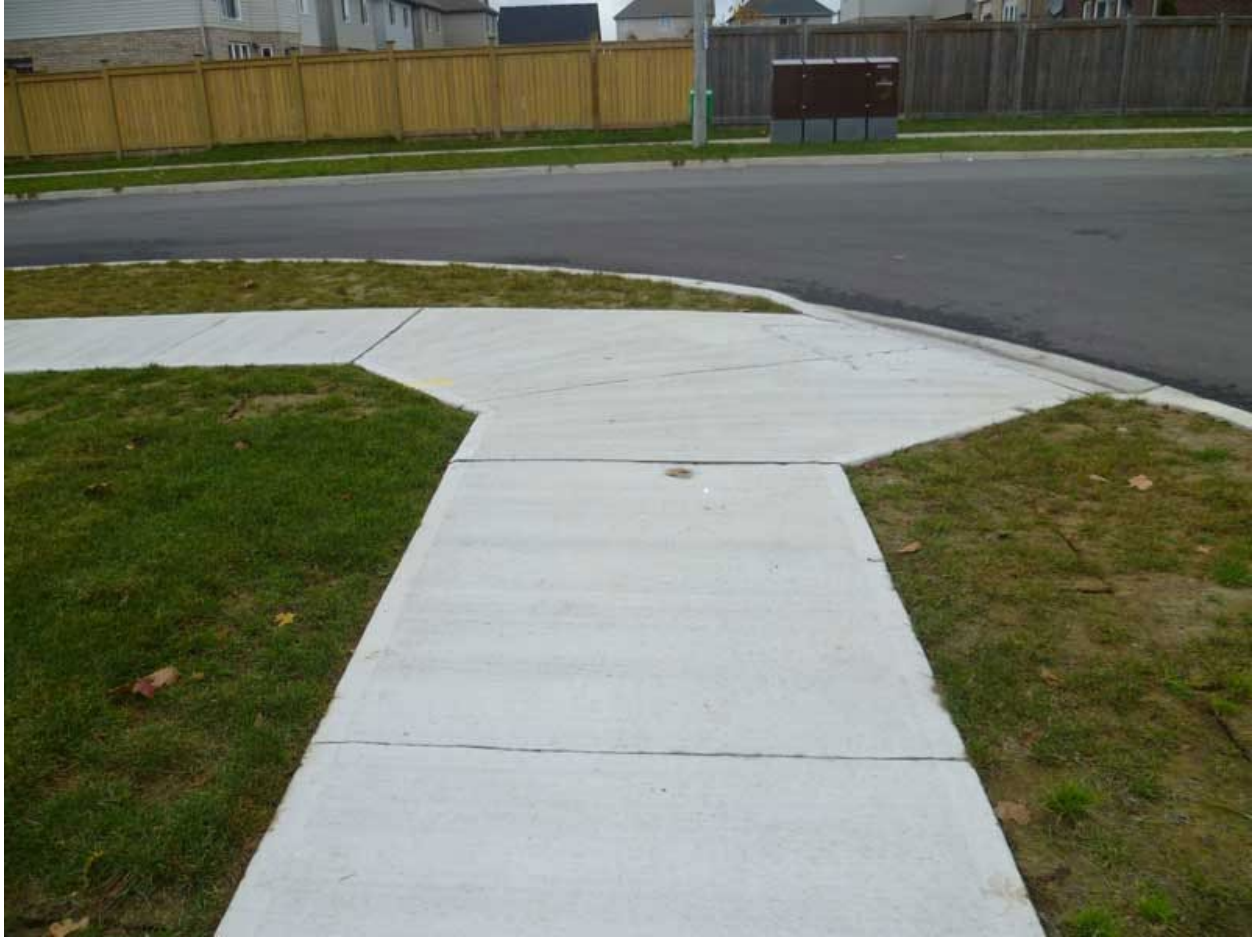
**Ramp without detectable warning surfaces** (or without the proper truncated domes) requires a reconstruction to insert the detectable warning surface into the concrete.

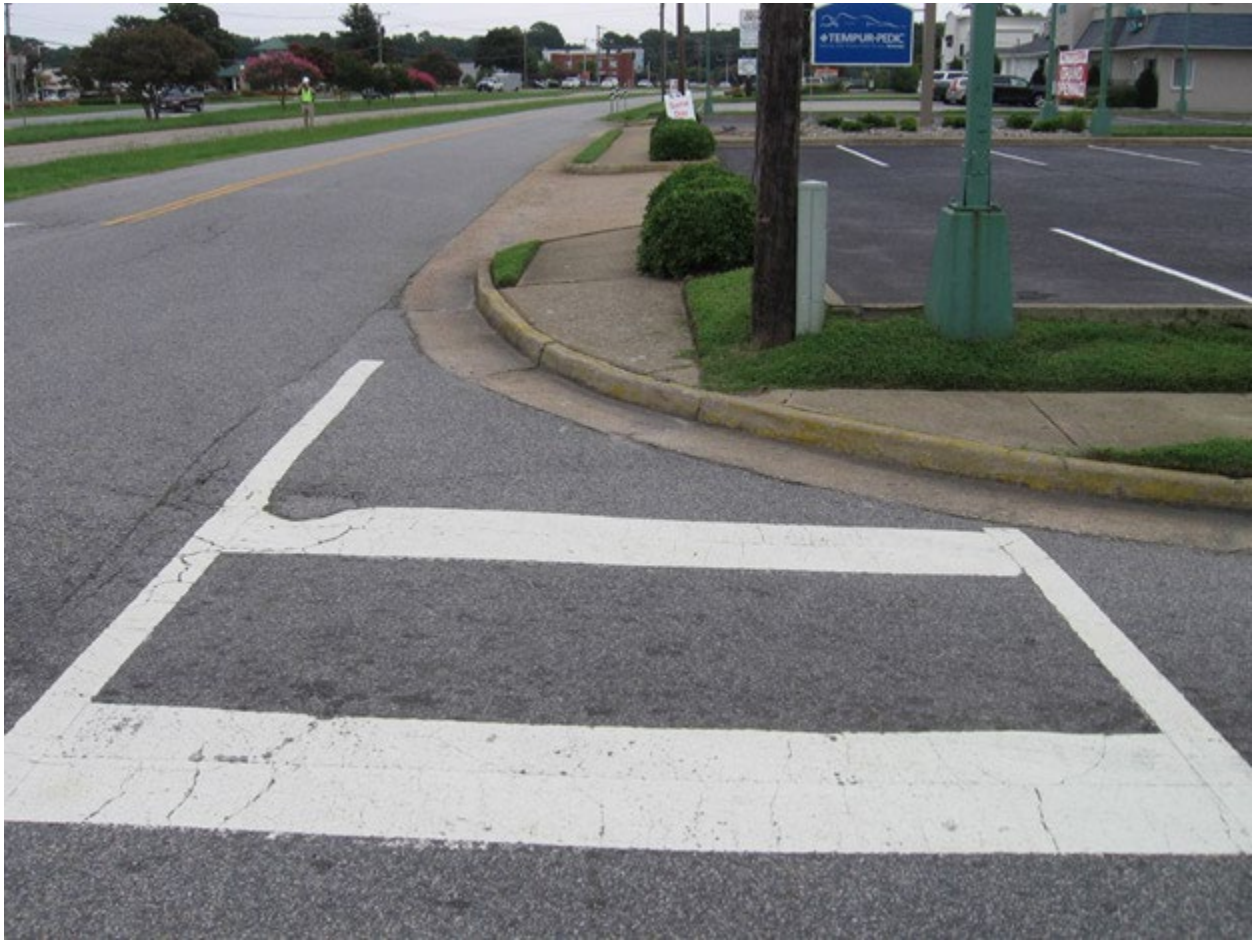
**No ramp no detectable warning surface** requires a removal and reconstruction of the corner on which the ramp is missing. The installed ramp should include proper detectable warning surfaces on the edge of the ramp. A new ramp should be designed to meet all ADA requirements.
