# Tooele City

## 2022

# Sign/Sidewalk Assessment and Budget Recommendations

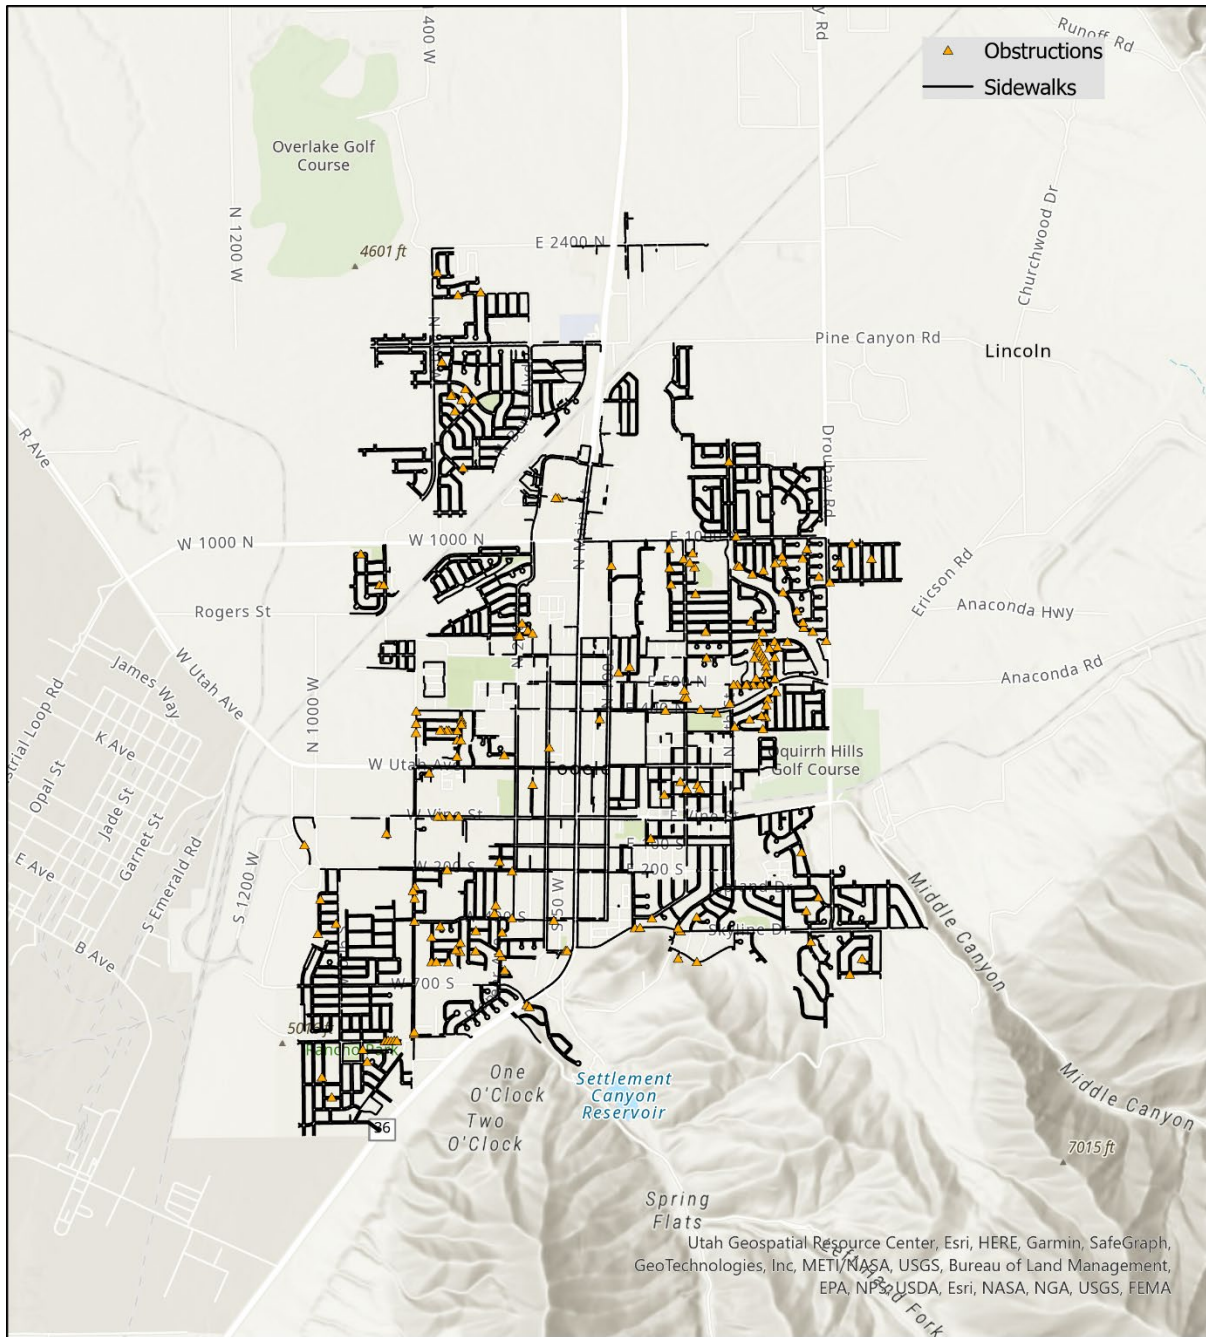
**Figure Two - Map of Sidewalk Obstructions**

**Obstructions** include the following issues that impact full use of the sidewalk: bushes, trees, landscaping, and mailboxes. Obstructions are single points that represent a section of sidewalk that needs to be corrected. Figure Two shows the locations of 188 obstructions.

Obstructions are not calculated as a cost. The cost of repairing these obstructions is left to the property owner. Tooele City is responsible for informing the property owner of said obstructions.

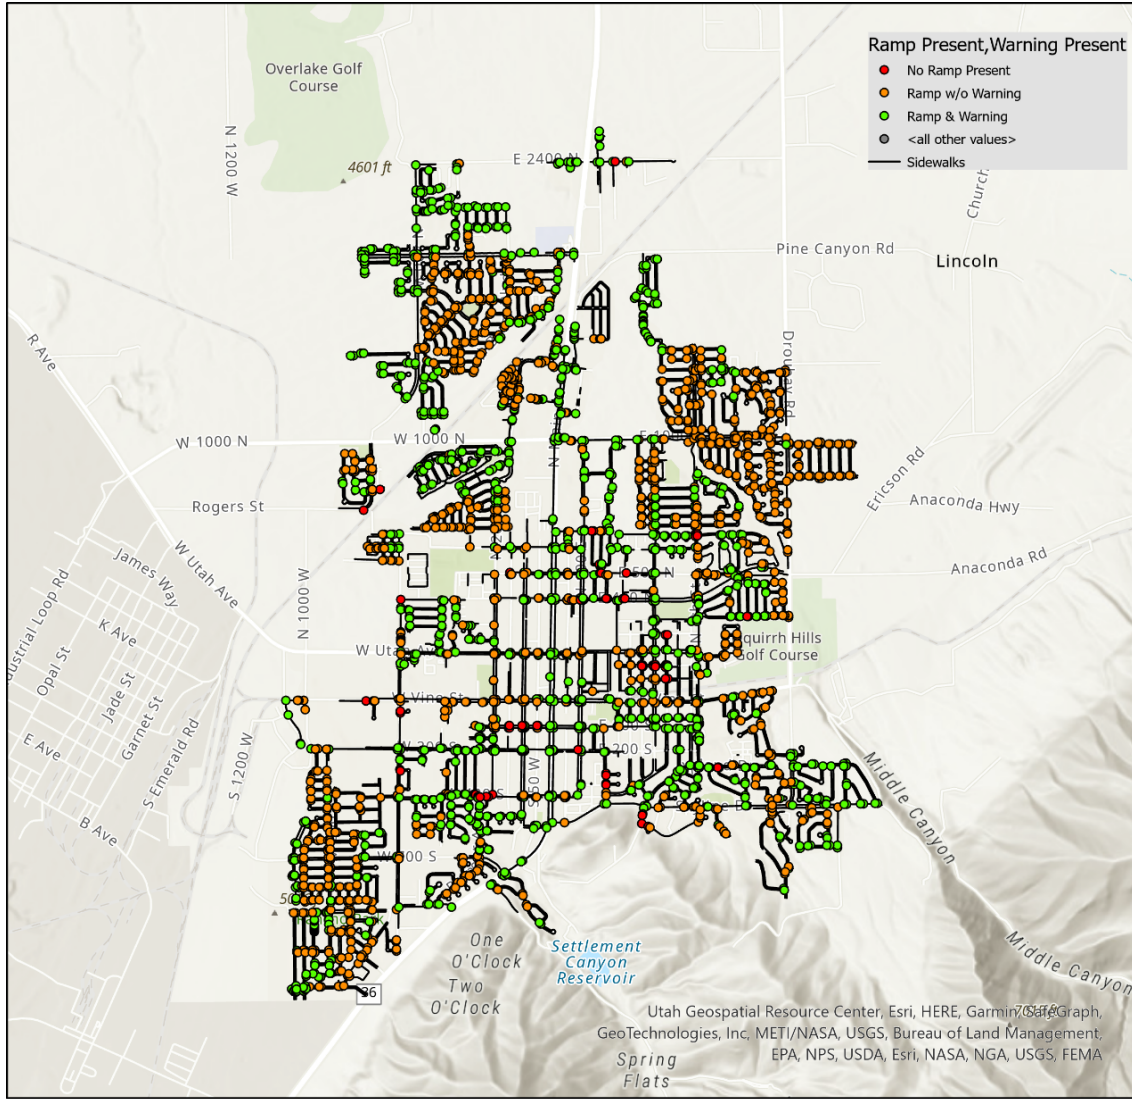
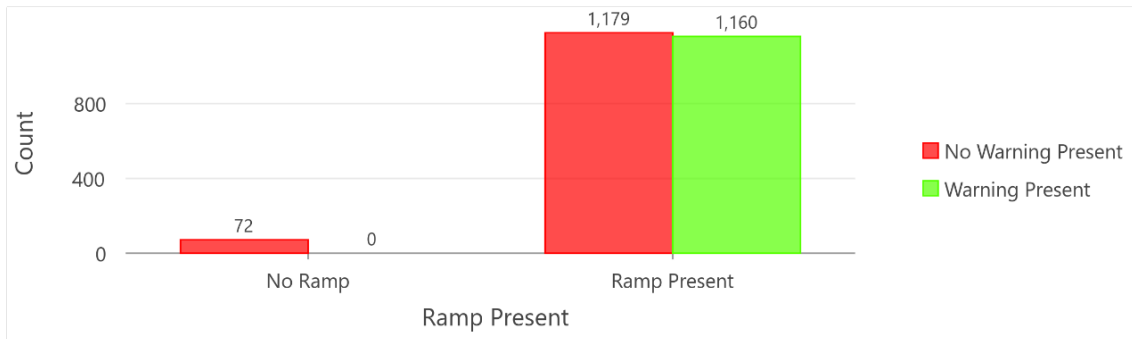
Figure Three - Map/Data for ADA Ramps

ADA ramp data includes the following: ramp with detectible warning surface, ramp without detectible warning surface, and no ramp/no detectible warning surface. Figure Three is a map/chart that which of the 2,411 crossing locations, over 50 percent need upgrades.

**No ramp no detectable warning surface** requires a removal and reconstruction of the corner on which the ramp is missing. The installed ramp should include proper detectable warning surfaces on the edge of the ramp. A new ramp should be designed to meet all ADA requirements.

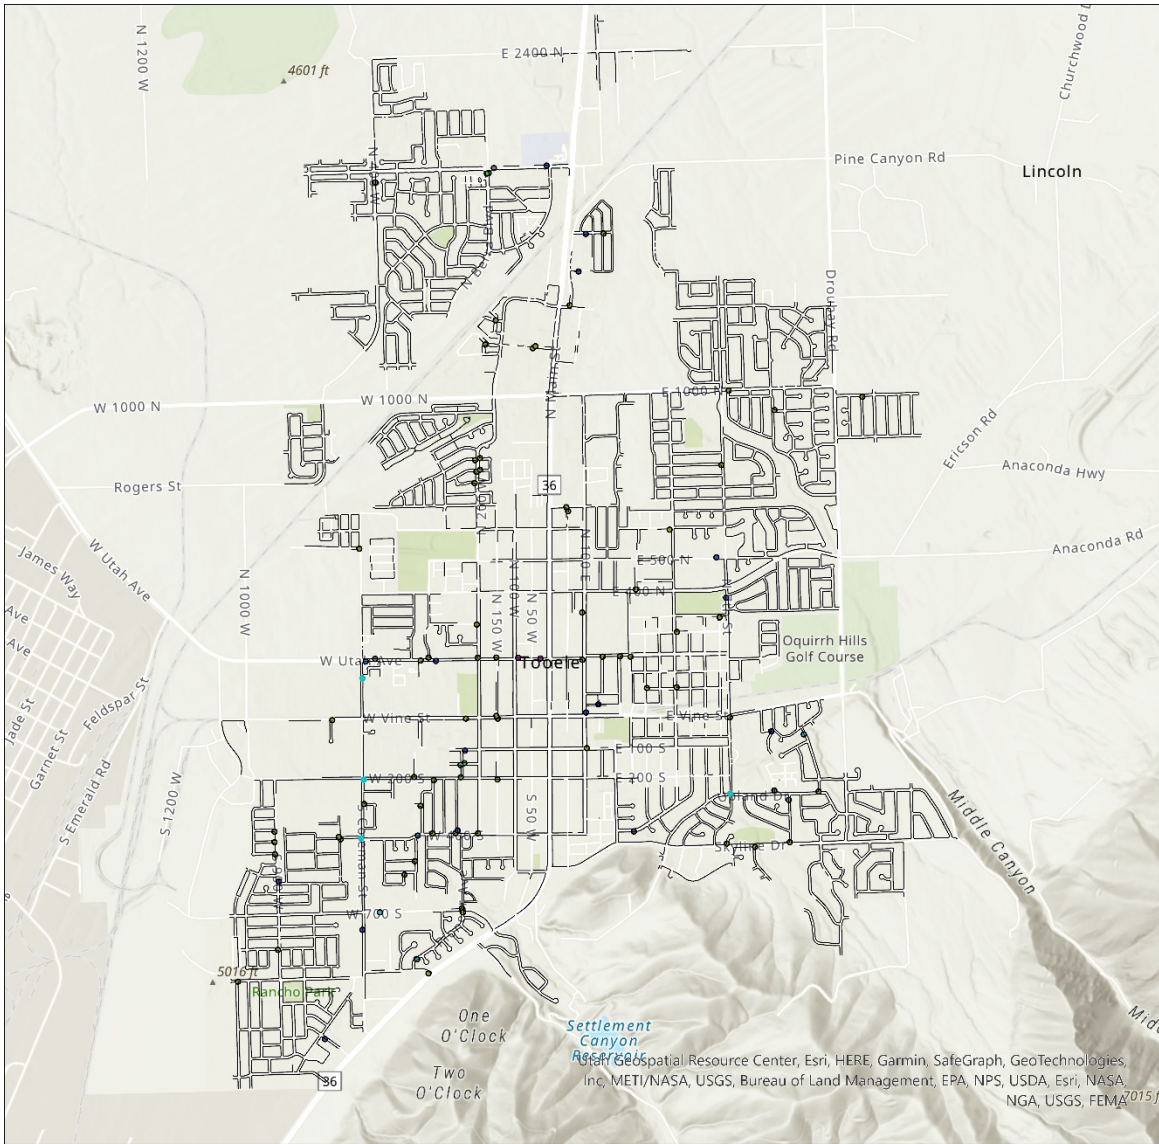
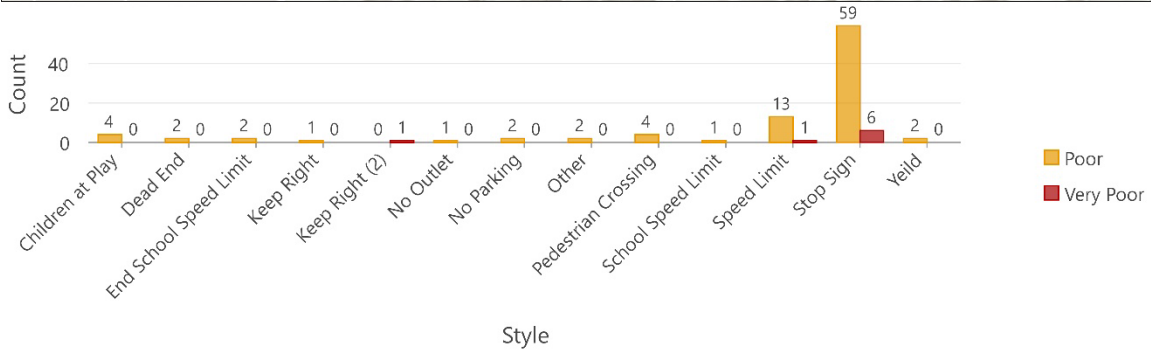
**Figure Four – Map/Data for Signs**

**Sign data** includes the many varieties of signs. The presented signs are rated at a poor or very poor rating. Figure Four is a map/chart that which of the 1080 signs recorded, just under 10 percent are rated with poor or very poor.

A budget was not developed for replacing signs. This is due to their being many ways to address sign replacements through the MUTCD. Many cities are just budgeting to replace a percentage of signs each year and then replacing them in zones. These cities have found this to be more cost effective than trying to evaluate the retro-reflectivity of the sign, which was outside of the scope of this study. Therefore, the process of budgeting and replacing these signs is left to the discretion of City.

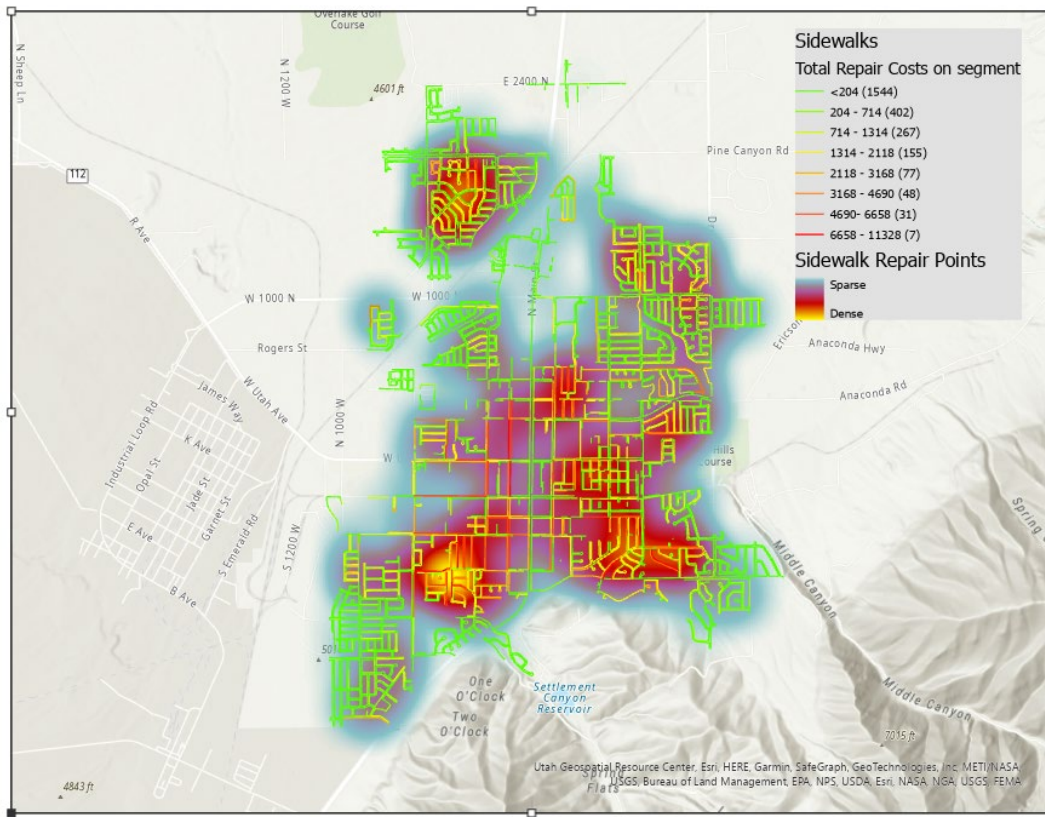
Figure Five - Total Repair Estimates for Sidewalk Distresses

Figure Five shows the total repair estimates for sidewalk distresses. The graphic illustrates a heatmap which shows the most expensive repair areas (shown in yellow). These areas are in the southwest, southeast, and northwest. This heatmap might be used to prioritize locations for initial projects.

Figure Five shows the overall costs of repairing all the sidewalk faults. The total cost of repairing all damage is \$1,377,510. The largest segment of repairs was ¼” trip hazards, totaling \$531,828.

In conclusion, the total estimated sidewalk and ramp repairs for Tooele City is \$2,125,710. It is recommended that budgets should be projected to complete the projects over the next 10 years. Therefore, an annual budget of \$212,000 is recommended for sidewalk repairs. It should be noted that additional distresses will develop over the next 10 years, so sidewalk maintenance will be an on-going requirement.

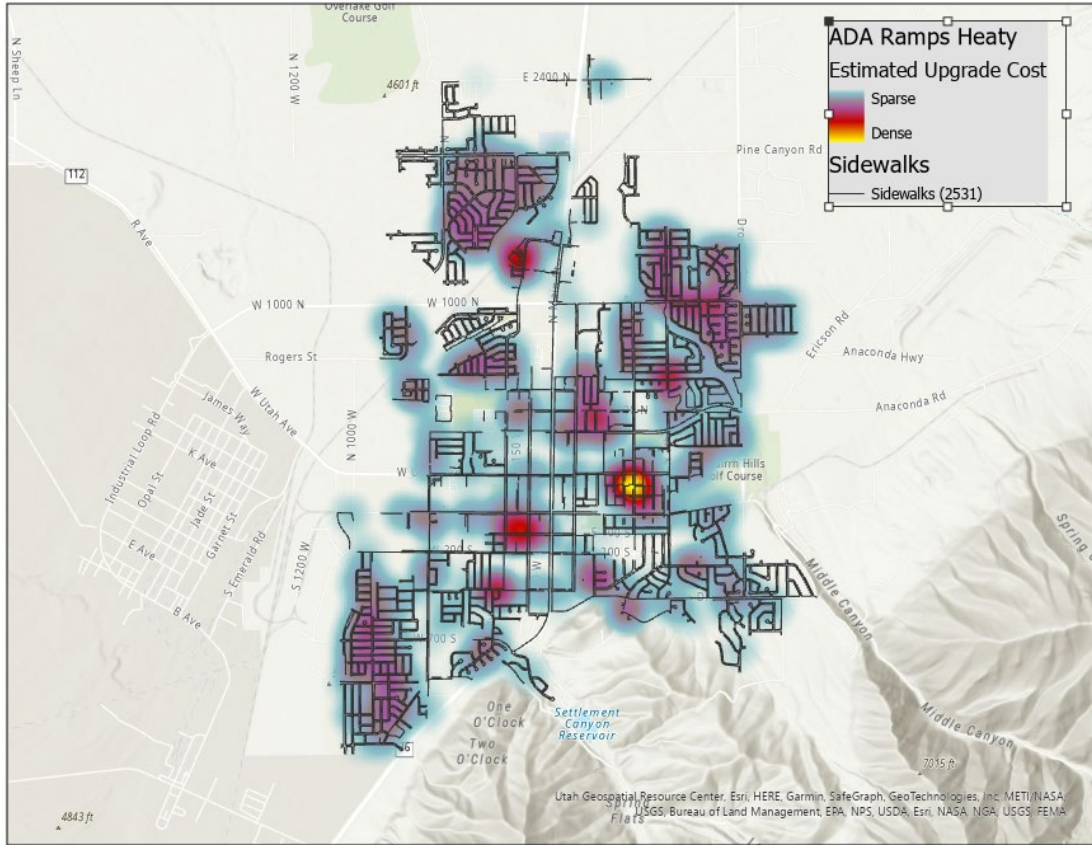
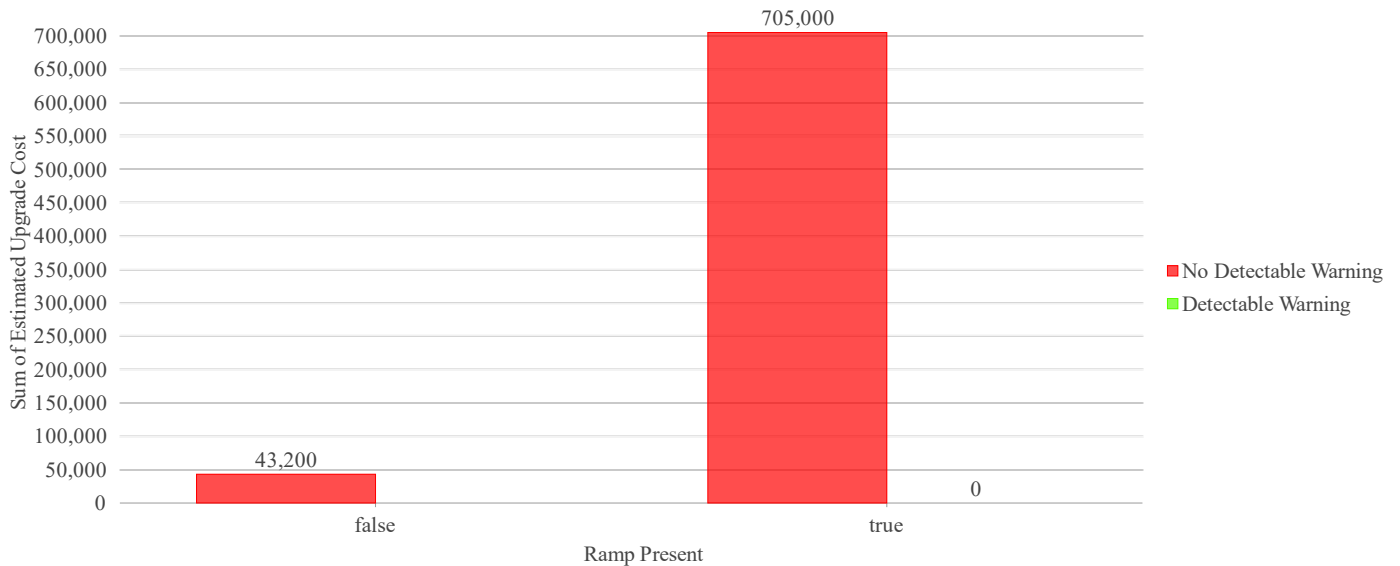
Figure Six - Total Repair Estimates for ADA Ramps

Figure Six shows the overall costs of repairing the ramp repair types. The total cost of repairing all ADA ramps is \$748,200. The heatmap below shows that ramp repair priorities may not be consistent with sidewalk repair priorities.
