**Geotechnical Study
One O'clock Hill
Settlement Canyon Road and UT-36
Tooele, Utah**

Project No. 219074

November 2, 2021

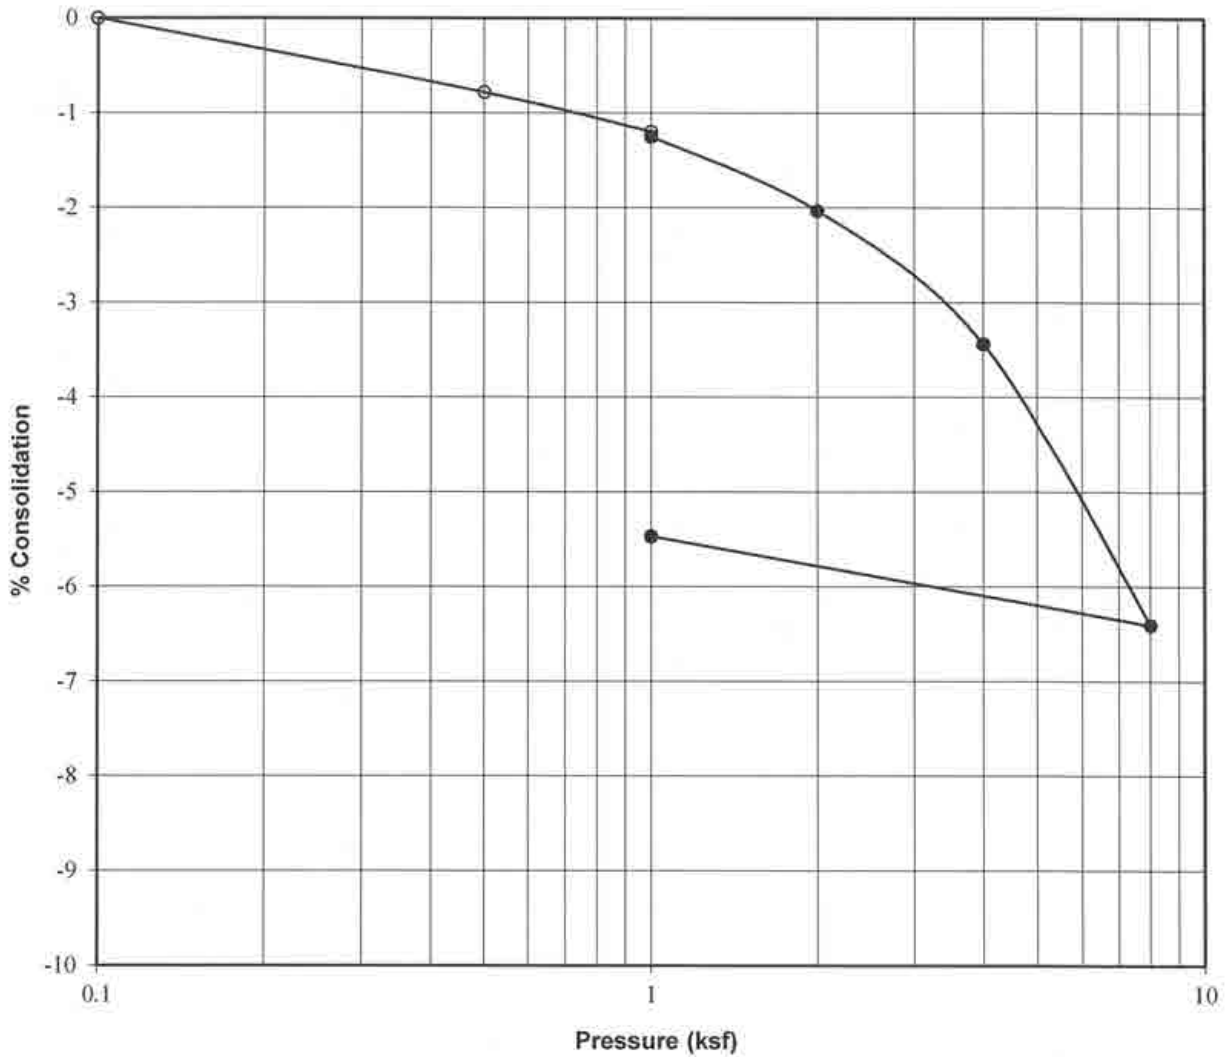
FIGURE NO.: 13

CONSOLIDATION - SWELL TEST

Project:	One O'clock Hill - Geotech
Location:	TP-9
Sample Depth, ft:	6½
Description:	Block
Soil Type:	Sandy Silty Clay (CL-ML)
Natural Moisture, %:	13
Dry Density, pcf:	98
Liquid Limit:	26
Plasticity Index:	4
Water Added at:	1 ksf
Percent Collapse:	0.1

As part of the consolidation test procedure, water was added to a sample to assess moisture sensitivity when the sample was loaded to an equivalent pressure of approximately 1,000 psf. The native clay soils have a negligible potential for collapse (settlement) and a slight potential for compressibility under increased moisture contents and anticipated load conditions.

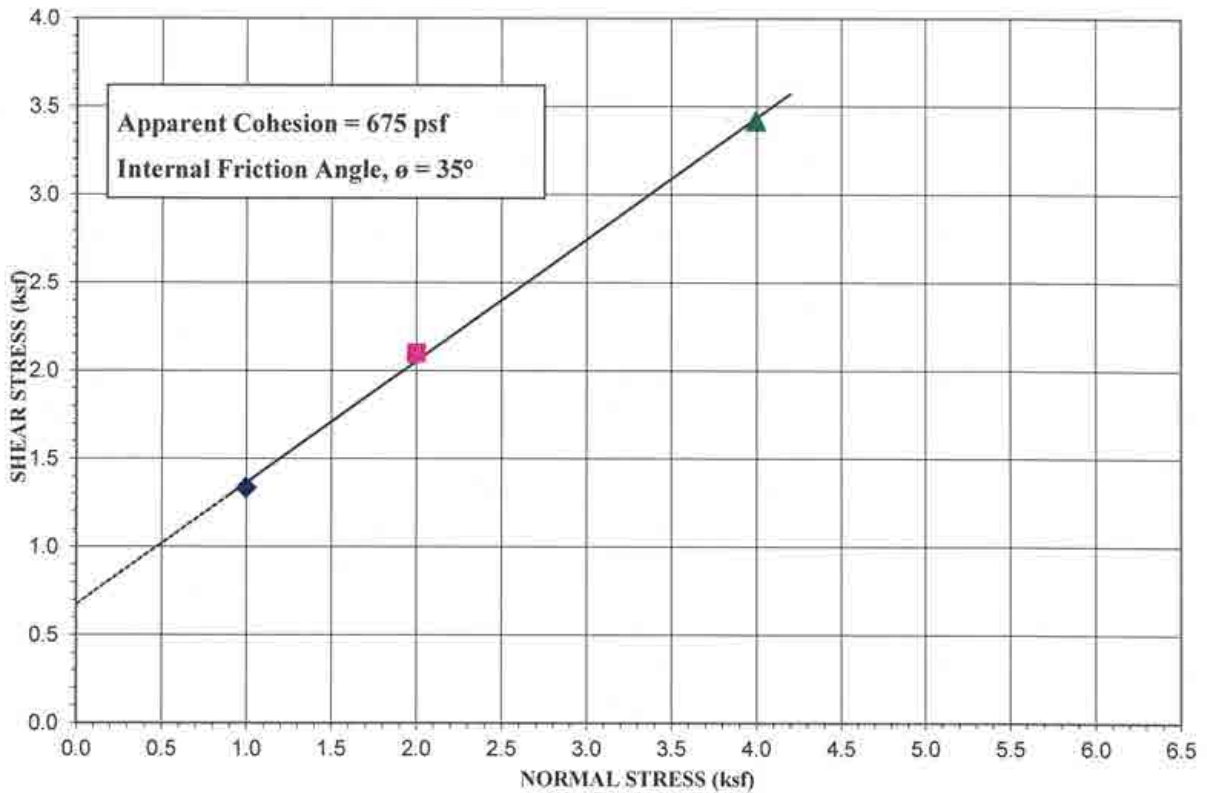
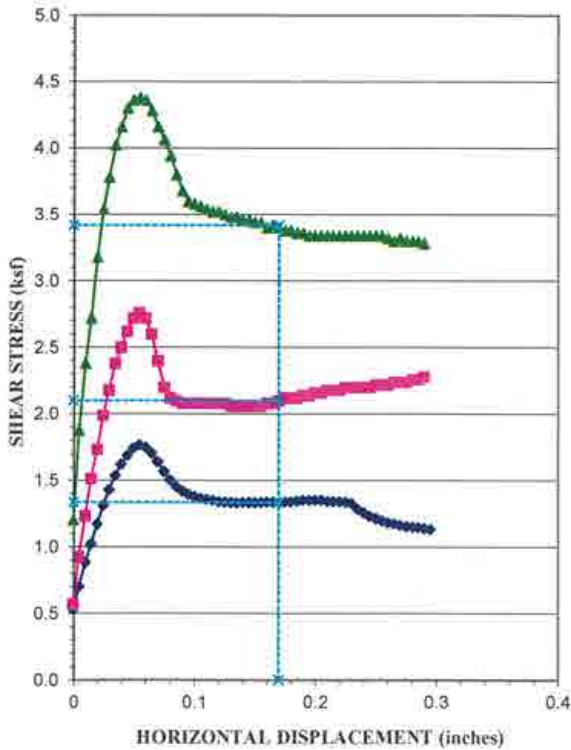
DIRECT SHEAR TEST

Source: TP-4	Depth: 4.5 FT	
Type of Test:	Consolidated Drained/Saturated	
Test No. (Symbol)	1 (◆)	2 (■) 3 (▲)
Sample Type	Remolded	
Initial Height, in.	1	1 1
Diameter, in.	2.4	2.4 2.4
Dry Density Before, pcf		
Dry Density After, pcf	120.9	122.8 120.2
Moisture % Before		
Moisture % After	13.9	14.1 13.8
Normal Load, ksf	1.0	2.0 4.0
Shear Stress, ksf	1.34	2.10 3.42
Strain Rate	.00008640 IN/SEC	
Sample Properties		
Cohesion, psf	675	
Friction Angle, ϕ	35	
Liquid Limit, %	22	
Plasticity Index, %	NP	
Percent Gravel	3	
Percent Sand	39	
Percent Passing No. 200 sieve	58	
Classification	ML

Representative soil samples collected during our field exploration were tested in the laboratory to assess pertinent engineering properties and to aid in refining field classifications, if needed. Tests performed included natural moisture contents, dry density tests, liquid and plastic limits determinations, mechanical (partial) gradation analyses, direct shear tests, and a one-dimensional consolidation test. The laboratory test results are also included on the attached *Test Pit Logs* at the respective sample depths, on Figure No. 14, *Consolidation-Swell Test*, on Figure Nos. 15 and 16, *Direct Shear Test*, and on Figure Nos. 17 through 20, *Stability Results*.

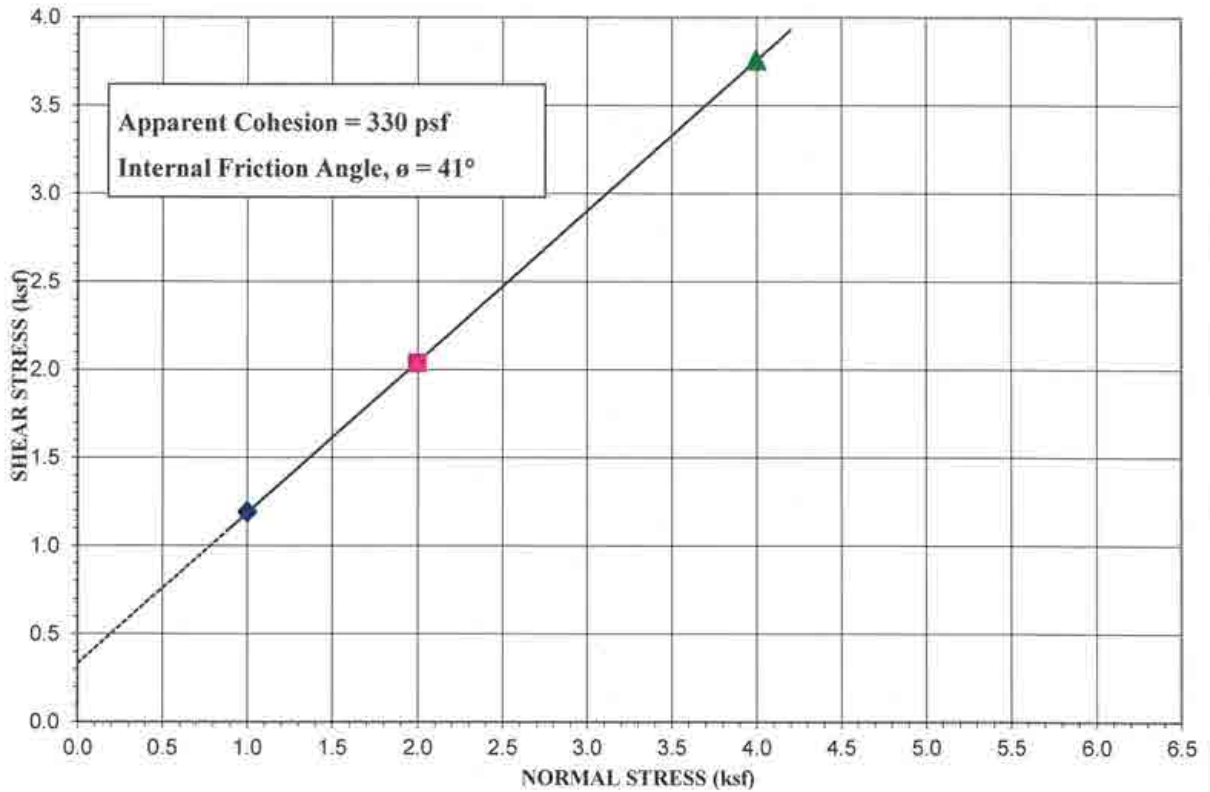
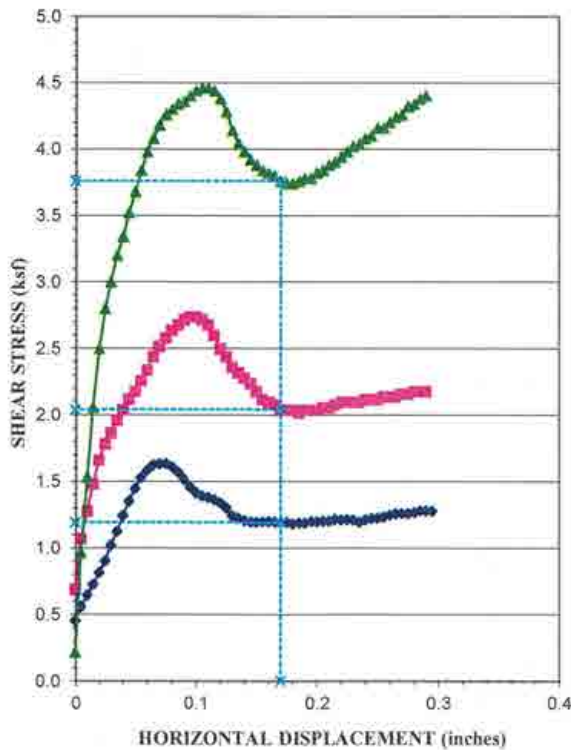
FIGURE NO.: 15

DIRECT SHEAR TEST

Source: TP-9	Depth: 2.5 FT	
Type of Test:	Consolidated Drained/Saturated	
Test No. (Symbol)	1 (◆)	2 (■)
Sample Type	Remolded	
Initial Height, in.	1	1
Diameter, in.	2.4	2.4
Dry Density Before, pcf		
Dry Density After, pcf	117.0	116.1
Moisture % Before		
Moisture % After	13.8	14.3
Normal Load, ksf	1.0	2.0
Shear Stress, ksf	1.19	2.04
Strain Rate	.00008640 IN/SEC	
Sample Properties		
Cohesion, psf	330	
Friction Angle, ϕ	41	
Liquid Limit, %	19	
Plasticity Index, %	NP	
Percent Gravel	62	
Percent Sand	26	
Percent Passing No. 200 sieve	12	
Classification	GP-GM

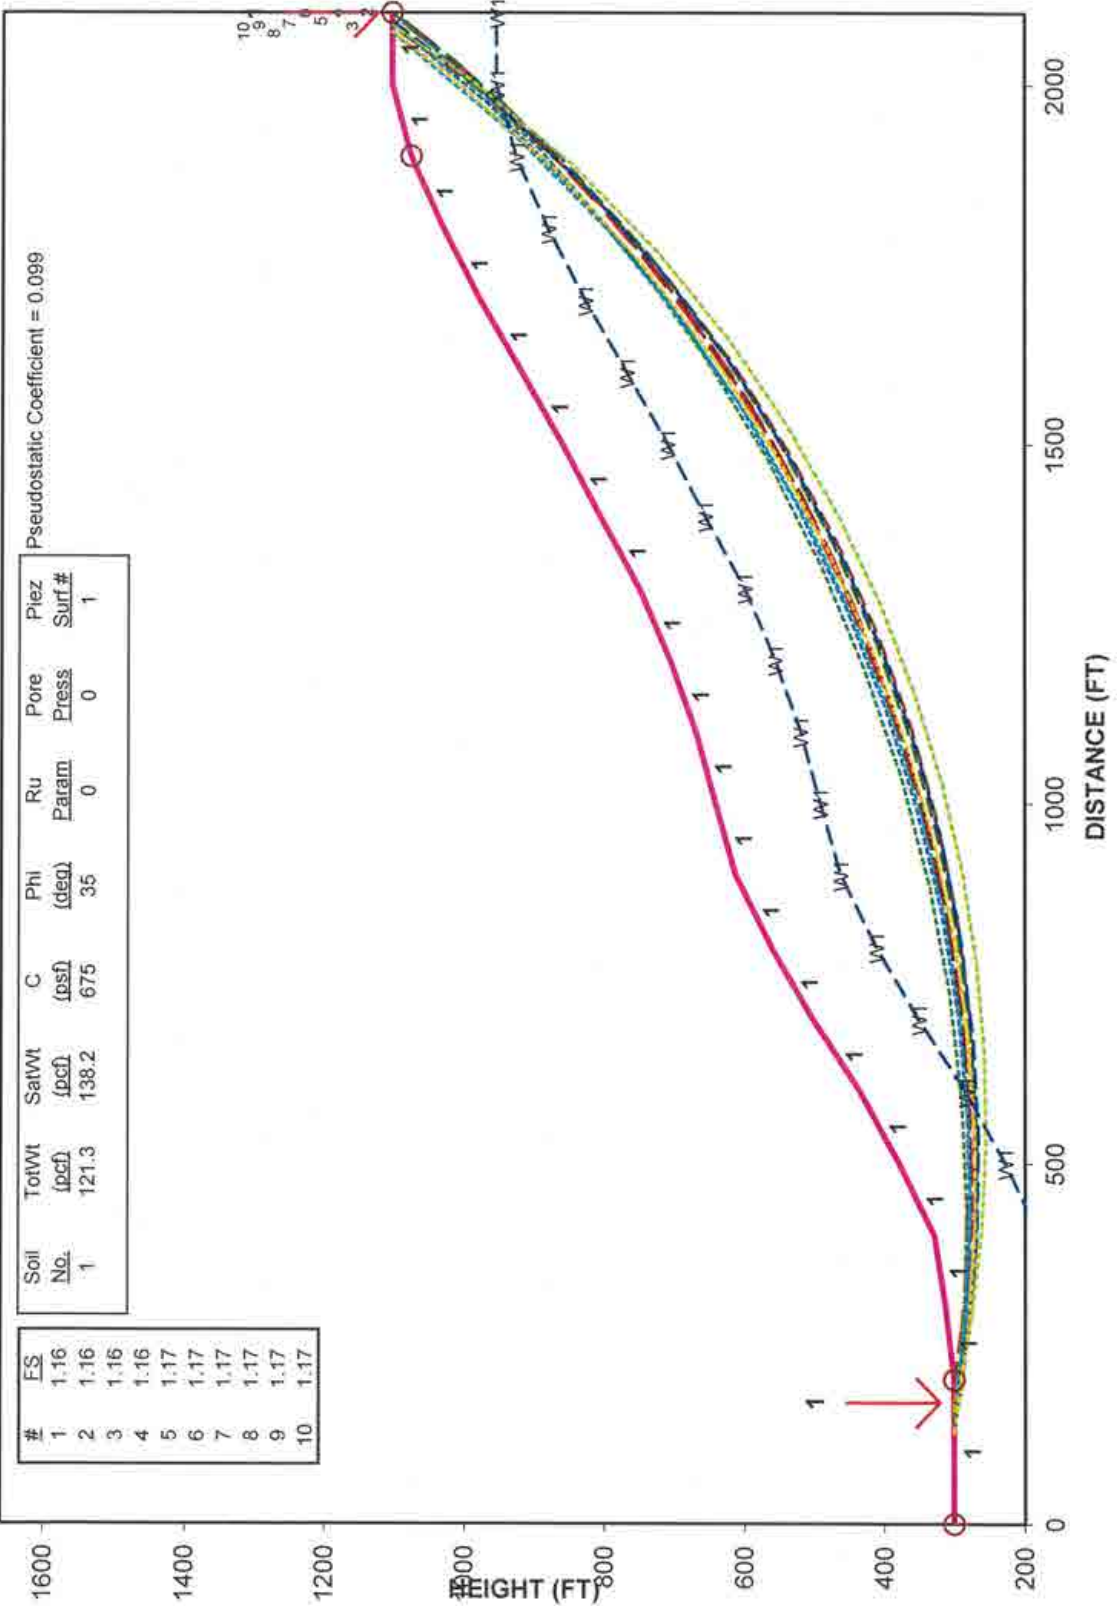
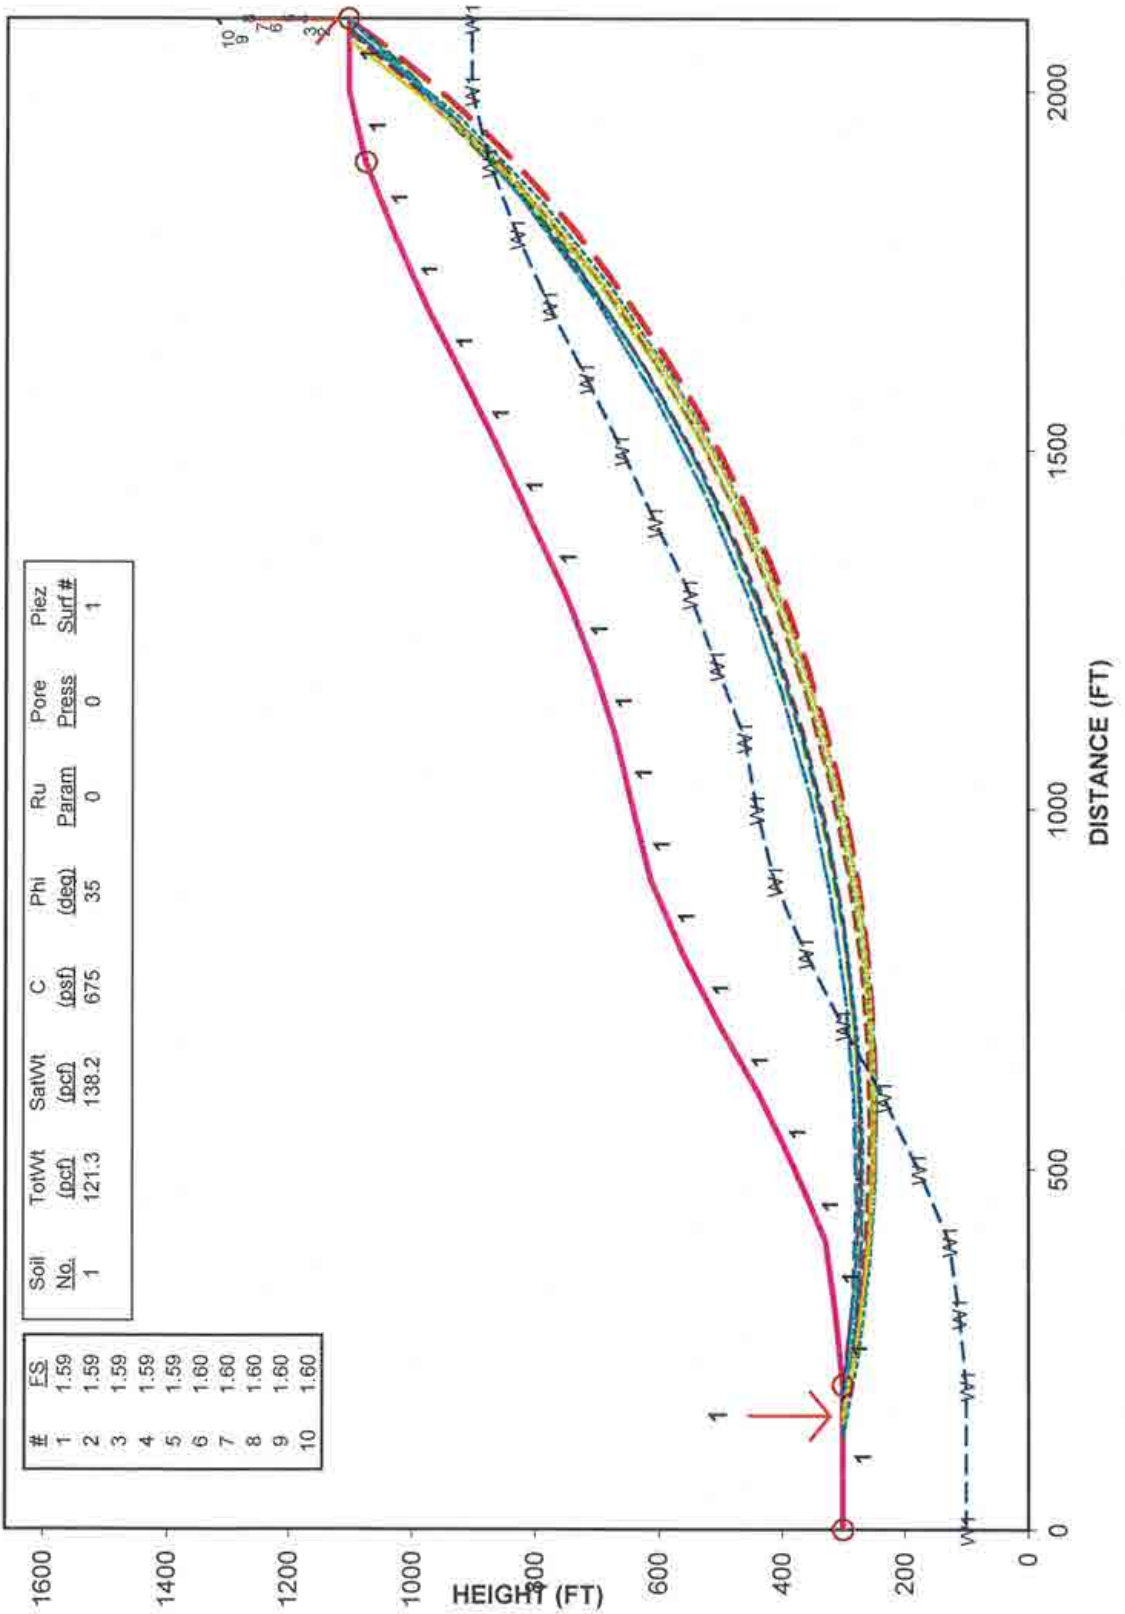
Soil No.	TotWt (pcf)	SatWt (pcf)	C (psf)	Phi (deg)	Ru Param	Pore Press	Piez Surf #
1	121.3	138.2	675	35	0	0	1

#	FS
1	1.16
2	1.16
3	1.16
4	1.16
5	1.17
6	1.17
7	1.17
8	1.17
9	1.17
10	1.17

STABILITY RESULTS

ONE O'CLOCK HILL~STATIC
 Ten Most Critical Surfaces. 219074AD .OPT Run By: Earthtec 10-22-21

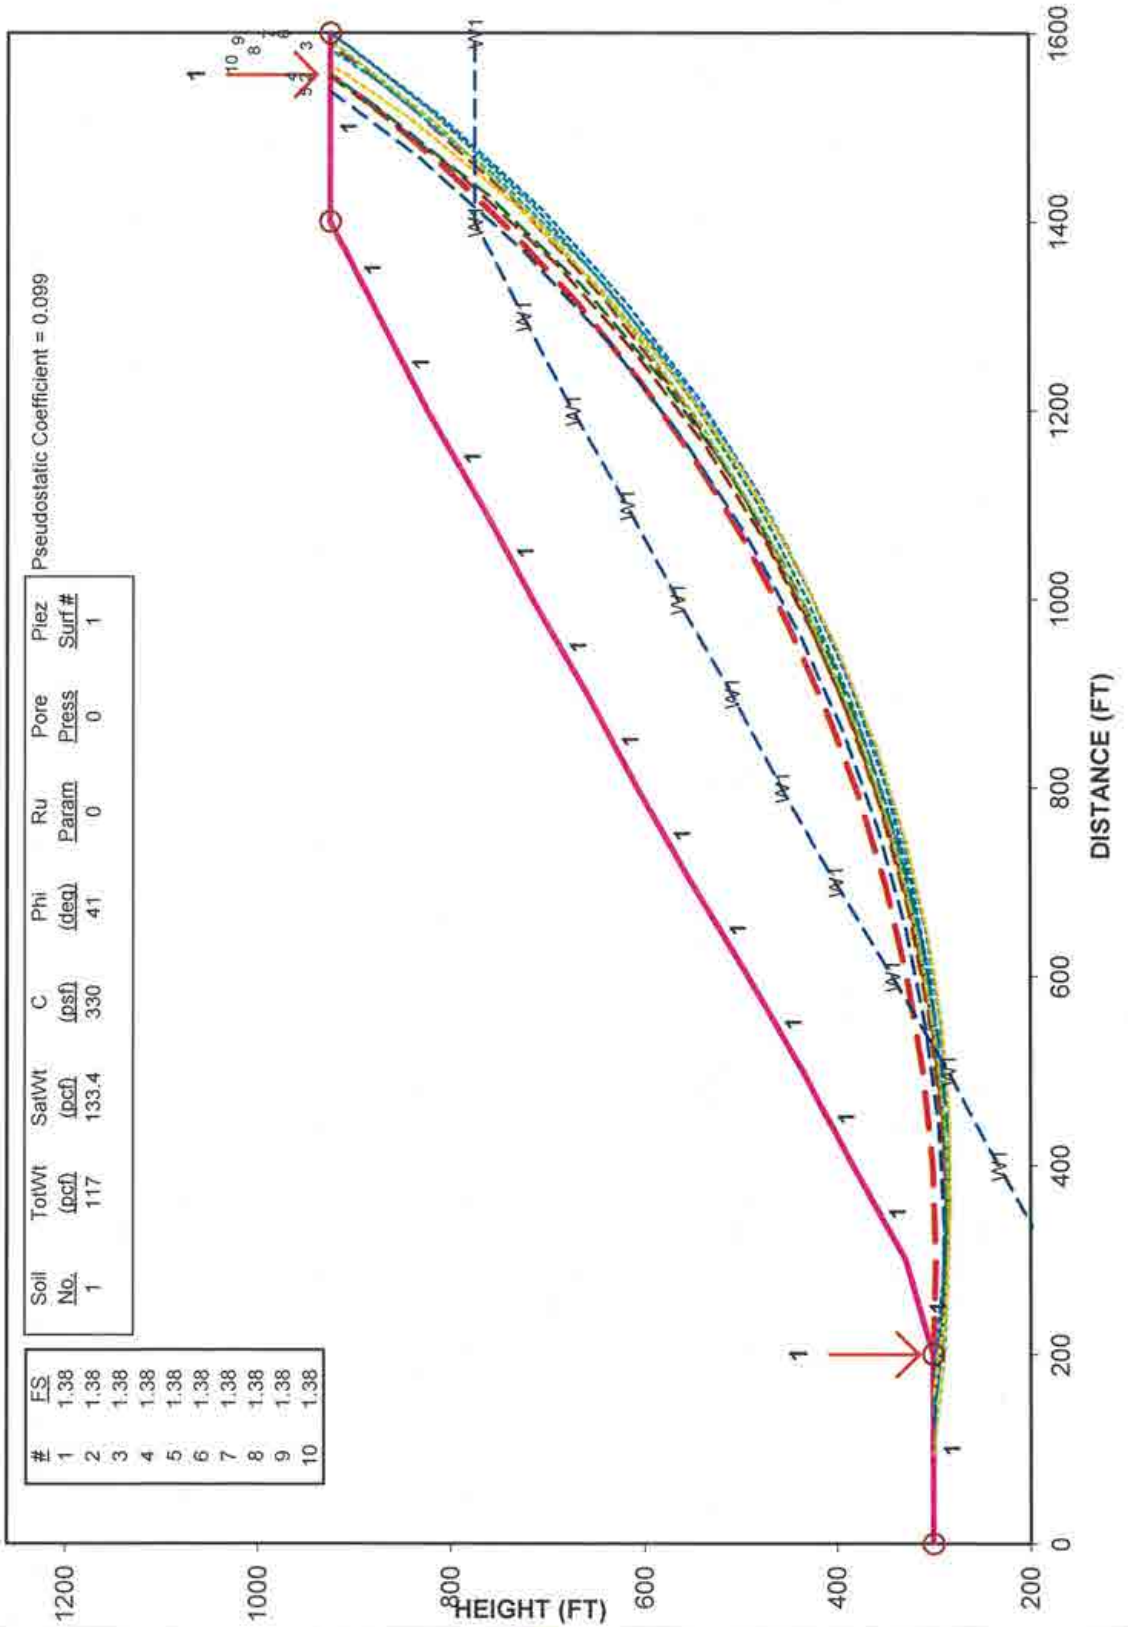
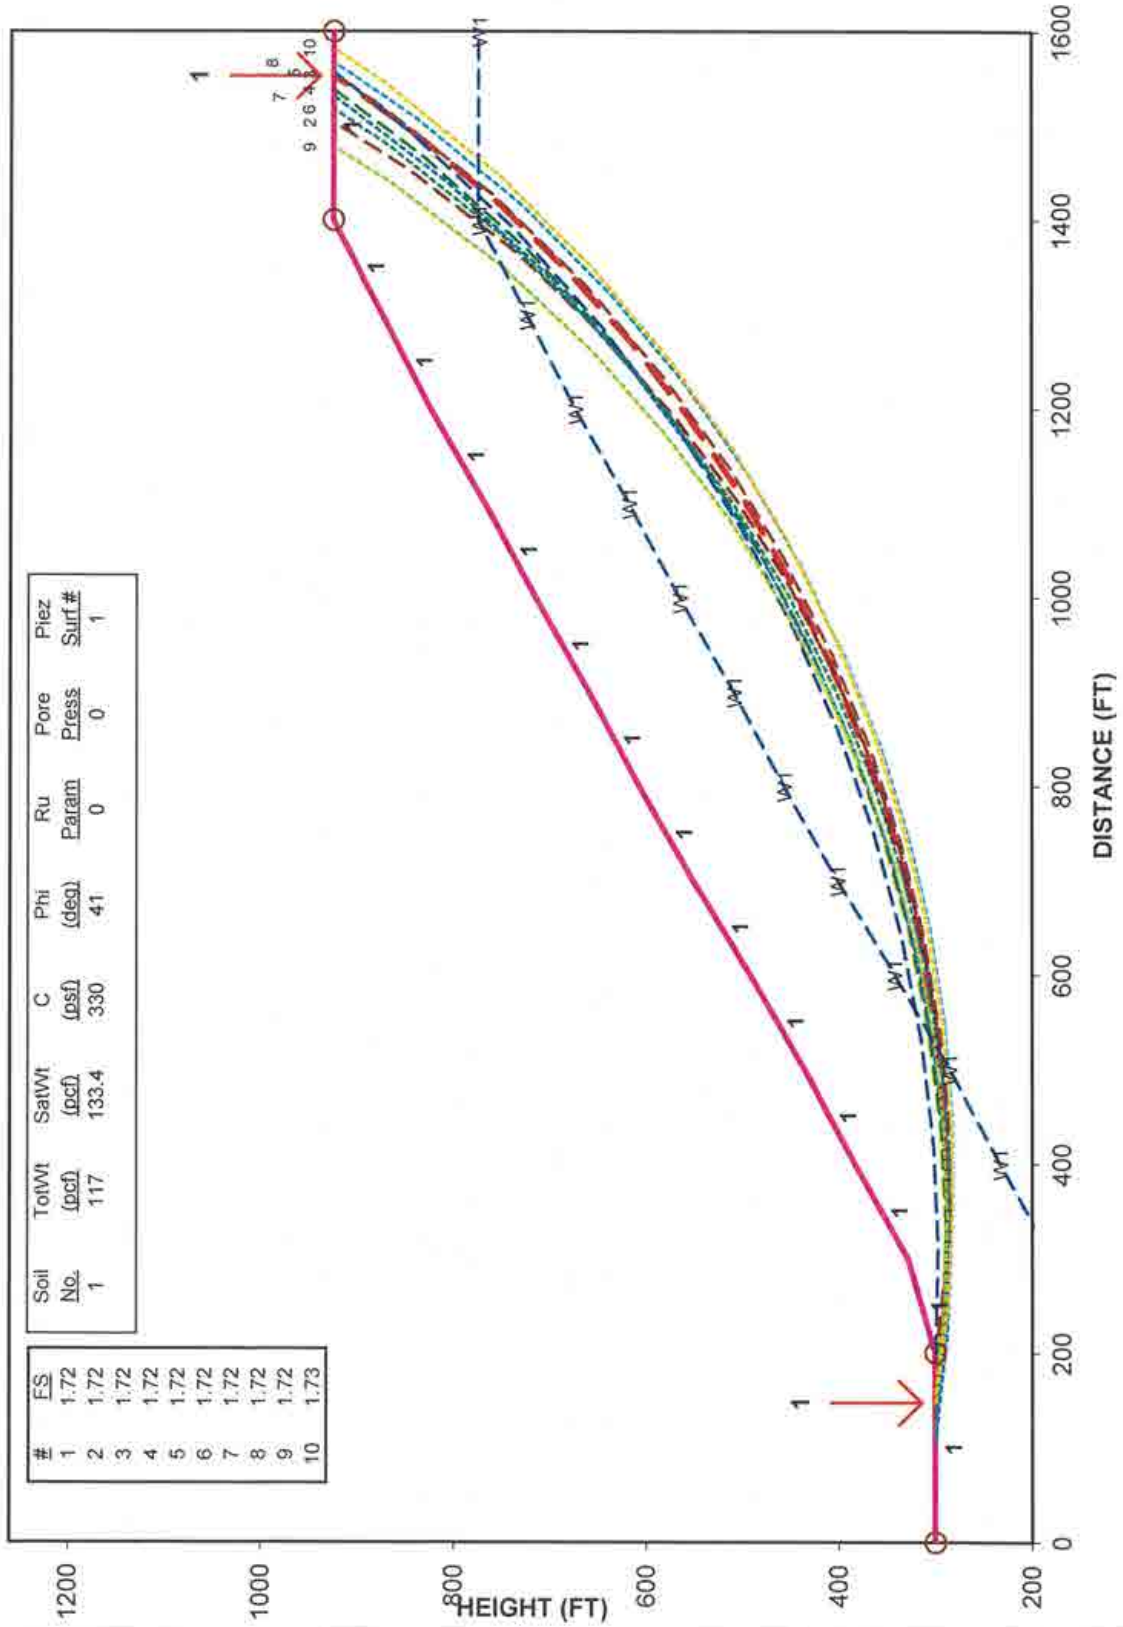
Soil No.	TotWt (pcf)	SatWt (pcf)	C (psf)	Phi (deg)	Ru Param	Pore Press	Piez Surf #
1	117	133.4	330	41	0	0	1

#	FS
1	1.38
2	1.38
3	1.38
4	1.38
5	1.38
6	1.38
7	1.38
8	1.38
9	1.38
10	1.38

STABILITY RESULTS

ONE O'CLOCK HILL~BB' STATIC
 Ten Most Critical Surfaces.. 219074BD .OPT Run By: Earthtec 11-01-21

Soil No.	ToiWt (pcf)	SatWt (pcf)	C (pcf)	Phi (deg)	Ru Param	Pore Press	Piez Surf #
1	117	133.4	330	41	0	0	1

#	FS
1	1.72
2	1.72
3	1.72
4	1.72
5	1.72
6	1.72
7	1.72
8	1.72
9	1.72
10	1.73

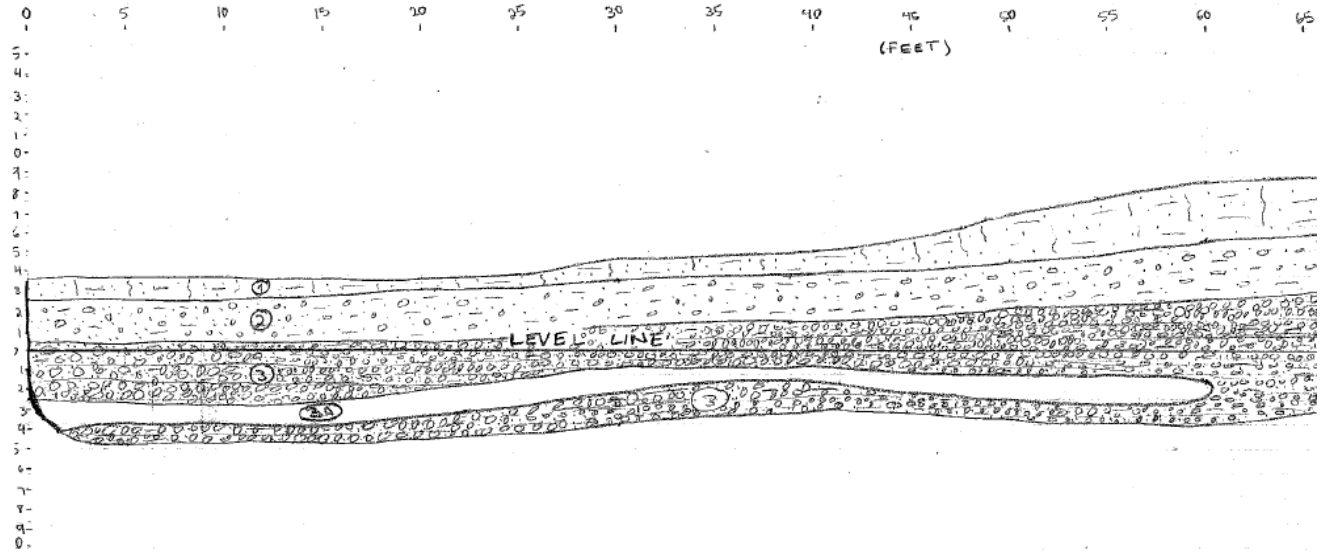
FIGURE NO.: 5

**EXPLORATION TRENCH ET-1 LOG
ONE O'CLOCK HILL - FRHS
UT-36 AND SETTLEMENT CANYON ROAD
TOOELE, UTAH**

Scale: 1 inch = 10 feet

Northeast Wall of Trench

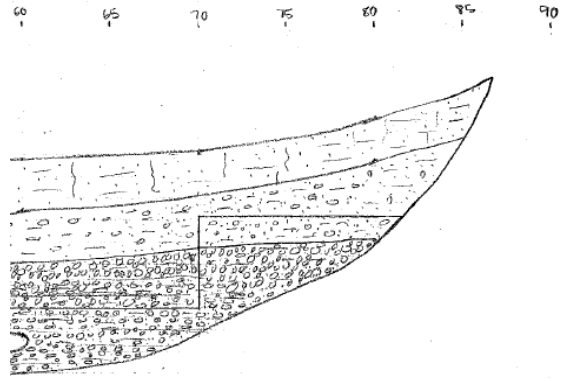
FIGURE NO.: 6a

**EXPLORATION TRENCH ET-1 LOG
ONE O'CLOCK HILL - FRHS
UT-36 AND SETTLEMENT CANYON ROAD
TOOELE, UTAH**

Scale: 1 inch = 10 feet

Northeast Wall of Trench

- 1) **Soil horizon A** – silty sand, brown, roots and organics, pinholes, low moisture
- 2) **Lake Bonneville Shoreline sand** – silty sand with gravel (SM), massive, sand matrix, 15% to 20% subangular to subrounded gravel, fine to coarse gravel, linear and mild calcite mottling, some roots diminished with depth, light brown to brown, very low moisture, poorly to moderately sorted, pinholes in fine sand pockets
- 3) **Alluvium Reworked by Lake Bonneville**– poorly graded gravel with silt and sand (GP-GM), massive, gravel matrix, laminar, very fine to coarse, subrounded to rounded gravel, fine to coarse sand, moderately to well sorted, tan to light brown, very low moisture
- 3A) **Lake Bonneville Near Shore** – poorly graded sand (SP), near shore very fine to fine sand, low energy environment, very well sorted, some ripple marks

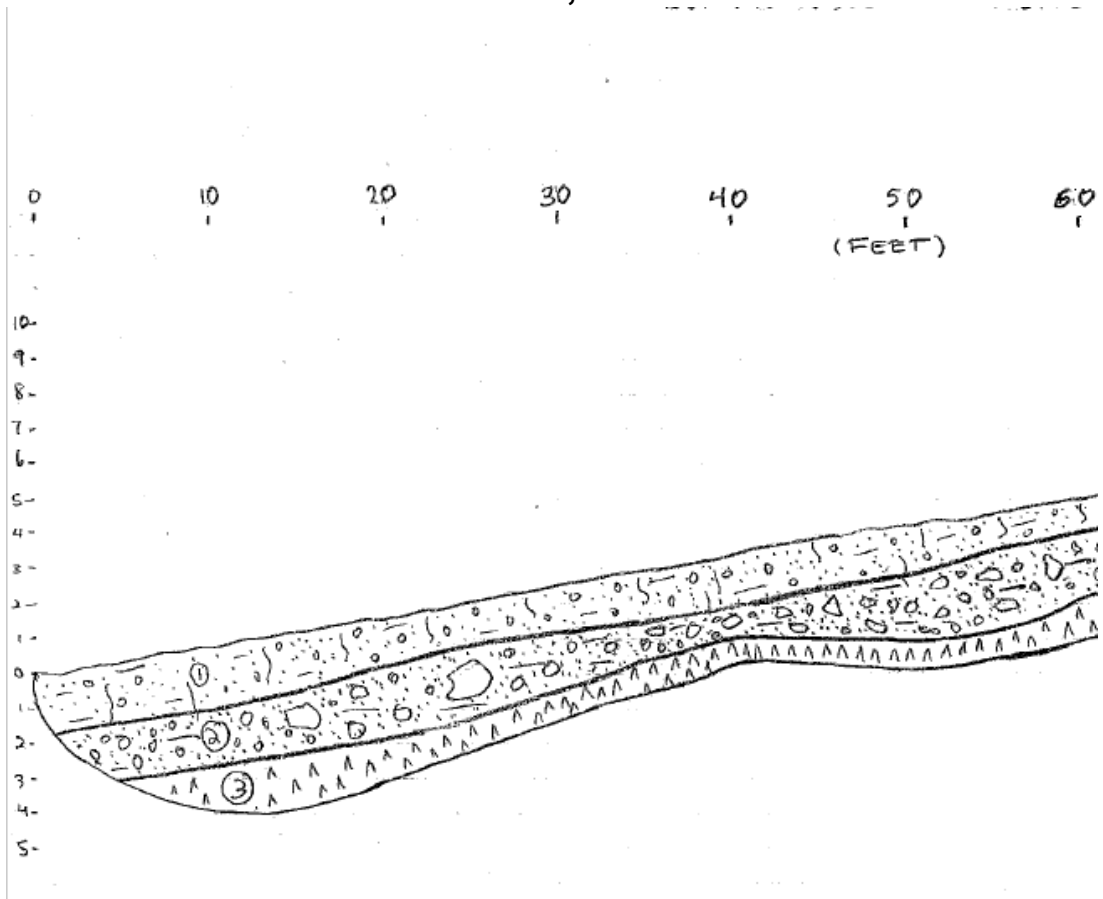
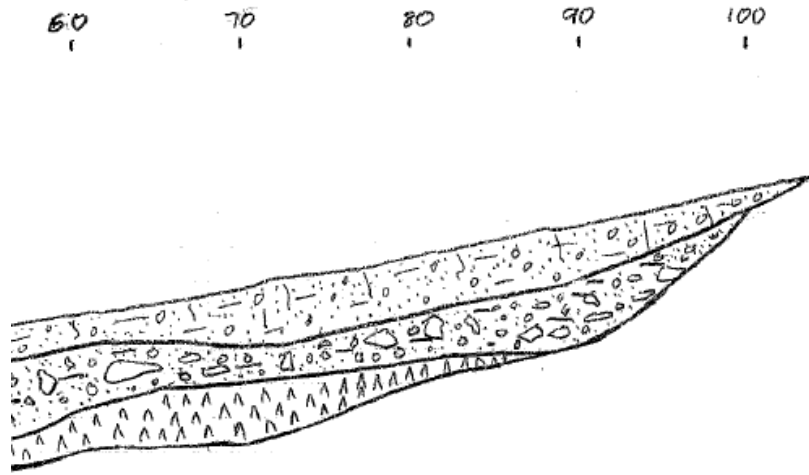
**EXPLORATION TRENCH ET-2 LOG
ONE O'CLOCK HILL - FRHS
UT-36 AND SETTLEMENT CANYON ROAD
TOOELE, UTAH**

Scale: 1 inch = 10 feet

Northeast Wall of Trench

Trend: N326°E

- 1) **Soil horizon A** – silty sand with gravel, dark brown, roots and organics, pinholes, low moisture
- 2) **Colluvium** – poorly graded with gravel with sand, silt, cobble and boulder (GM), massive, medium to very coarse, subangular to subrounded gravel, massive, poorly sorted, approximately 75% clast, 25% soil, gravel and cobbles are mostly quartzite, some limestone, light brown to brown, roots diminishing with depth.
- 3) **Weathered Bedrock** – mainly quartzite, highly fractured, some calcite mottling on top, light tan to tan, difficult to determine the orientation.

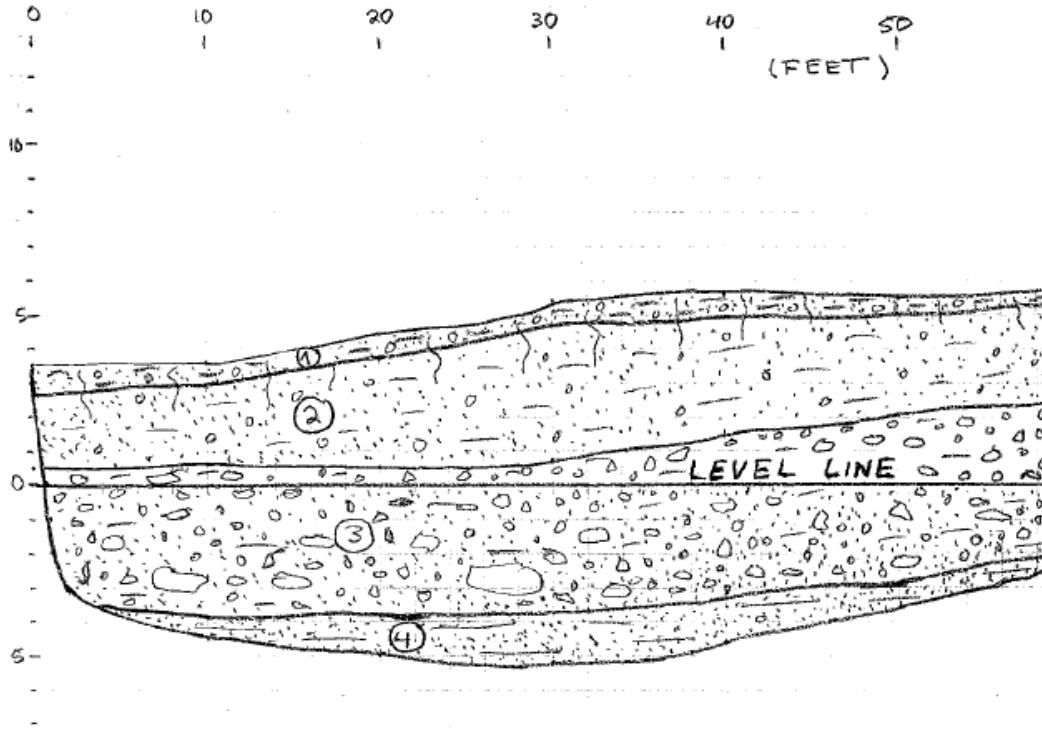
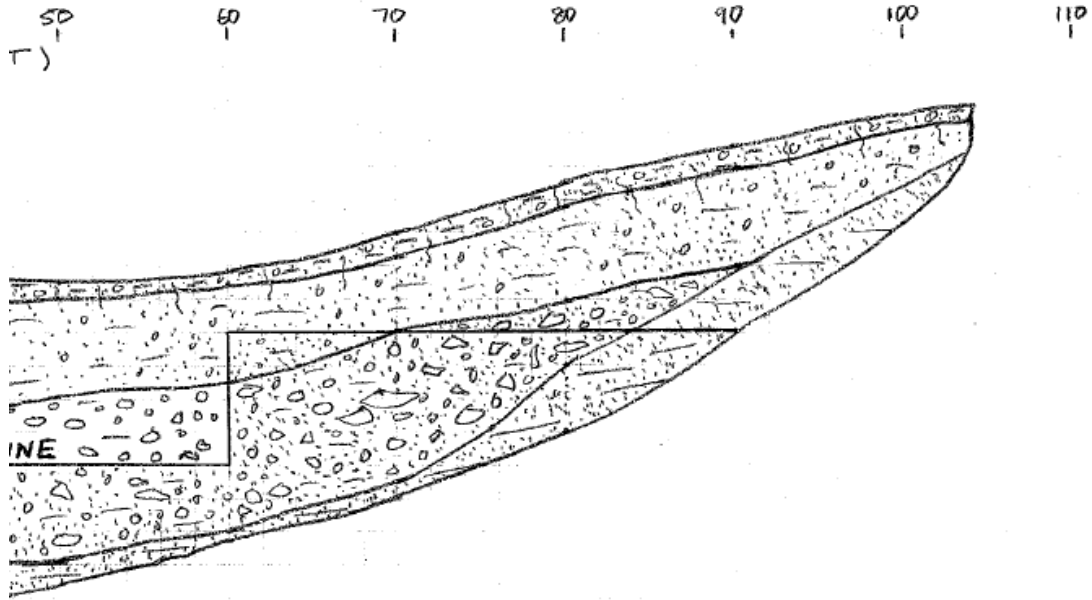
**EXPLORATION TRENCH ET-3 LOG
ONE O'CLOCK HILL - FRHS
UT-36 AND SETTLEMENT CANYON ROAD
TOOELE, UTAH**

Scale: 1 inch = 10 feet

Northeast Wall of Trench

Trend: N329°E

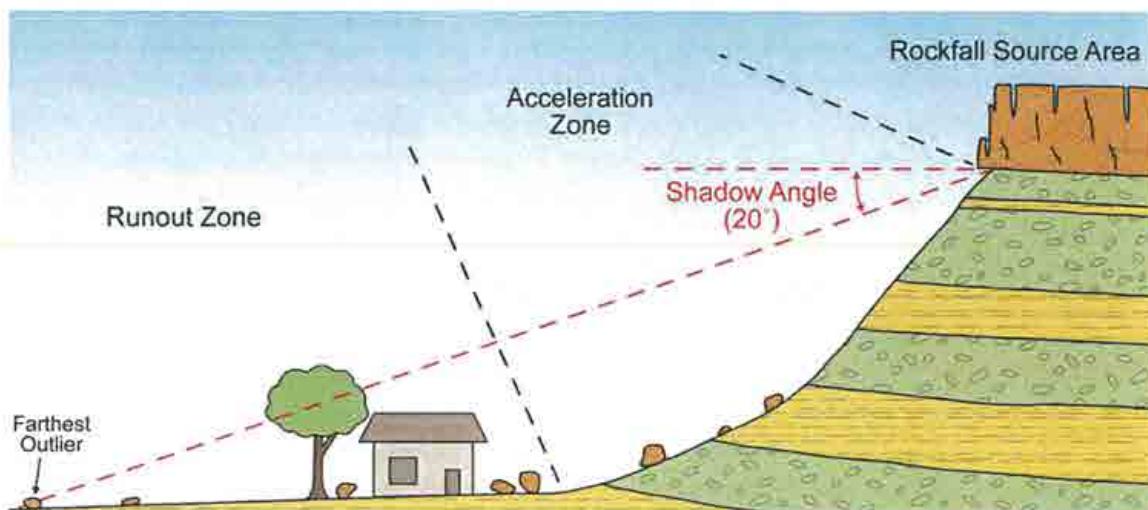
A rock-fall geologic study area consists of three components: (1) a rock source, in general defined by bedrock geologic units that exhibit relatively consistent patterns of rock-fall susceptibility throughout the study area, (2) an acceleration zone, where rock fall debris detached from the source gain momentum as it travels downslope—this zone often includes a talus slope, which becomes less apparent with decreasing relative hazard and is typically absent where the hazard is low, and finally (3) a runout zone (rock-fall shadow zone), which includes gentler slopes where boulders have rolled or bounced beyond the base of the acceleration zone. (Lund, et al., 2008 in County Code 17.59.030 (3)).

Typical components of a rockfall path profile are presented below (modified from Lund, et al., 2008):

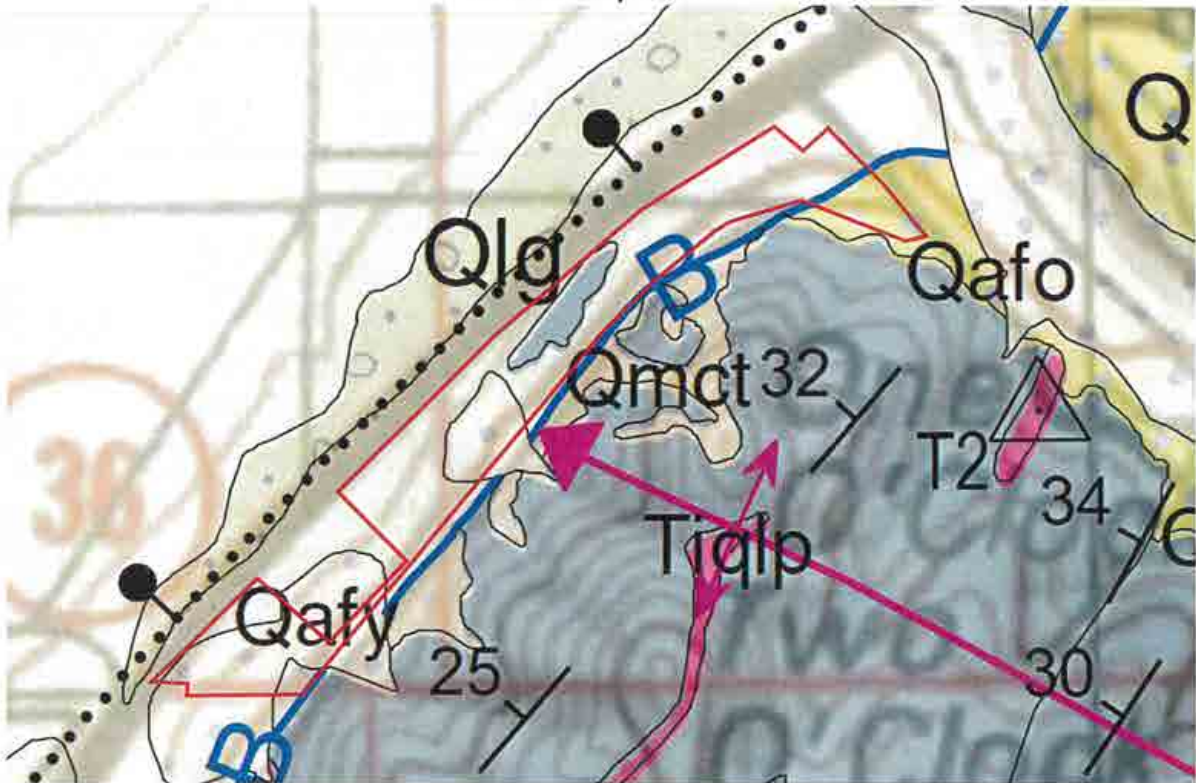
GEOLOGIC MAP
ONE O'CLOCK HILL
SETTLEMENT CANYON ROAN AND UT-36
TOOELE, UTAH

Utah Geological Survey (UGS) open file report 669 map: "Interim Geologic Map of the Tooele 30' x 60' Quadrangle, Tooele, Salt Lake, and Davis Counties, Utah, 2017,
 by Donald L. Clark, Charles G. Oviatt, and David A. Dinter.

IPobmu **Oquirrh Group, Bingham Mine Formation, upper member (Upper Pennsylvanian, Virgilian-Missourian)** – Light-gray to tan, thinly color-banded and locally cross-bedded quartzite with interbedded thin, light- to medium-gray, calcareous, fine-grained sandstone, limestone, and siltstone; several of the thin calcareous units are locally important as marker beds; upper-lower member contact is placed at base of the Manefay limestone marker bed; unit is very similar to the lower member above the Commercial Limestone (Swensen, 1975); Virgilian and Missourian fusulinids (*Triticites*) are reported from the Markham Peak section (R.C. Douglass in Tooker and Roberts, 1970), and Welsh and James (1961) reported a Virgilian and Missourian age for the entire formation; 2200 feet (670 m) thick at the Bingham district (Swensen, 1975).

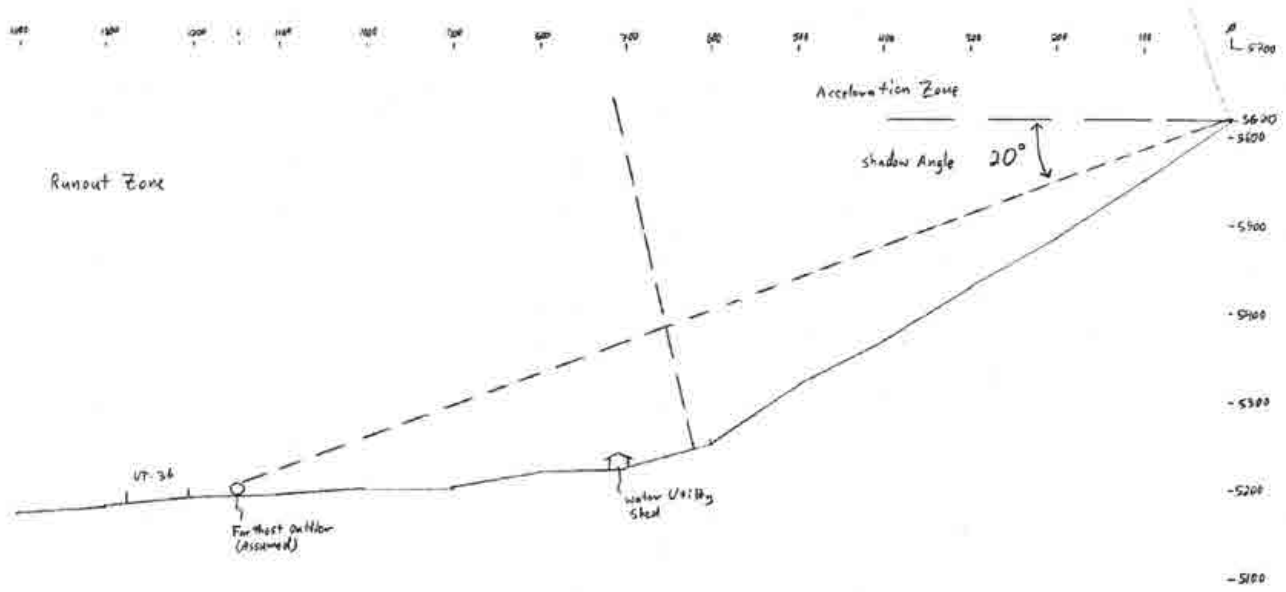
FIGURE NO.: 2b

SHADOW ANGLE DETERMINATION ONE O'CLOCK HILL ONE O'CLOCK HILL SETTLEMENT CANYON ROAD AND UT-36 TOOELE, UTAH

One O'clock Hill Shadow Angle

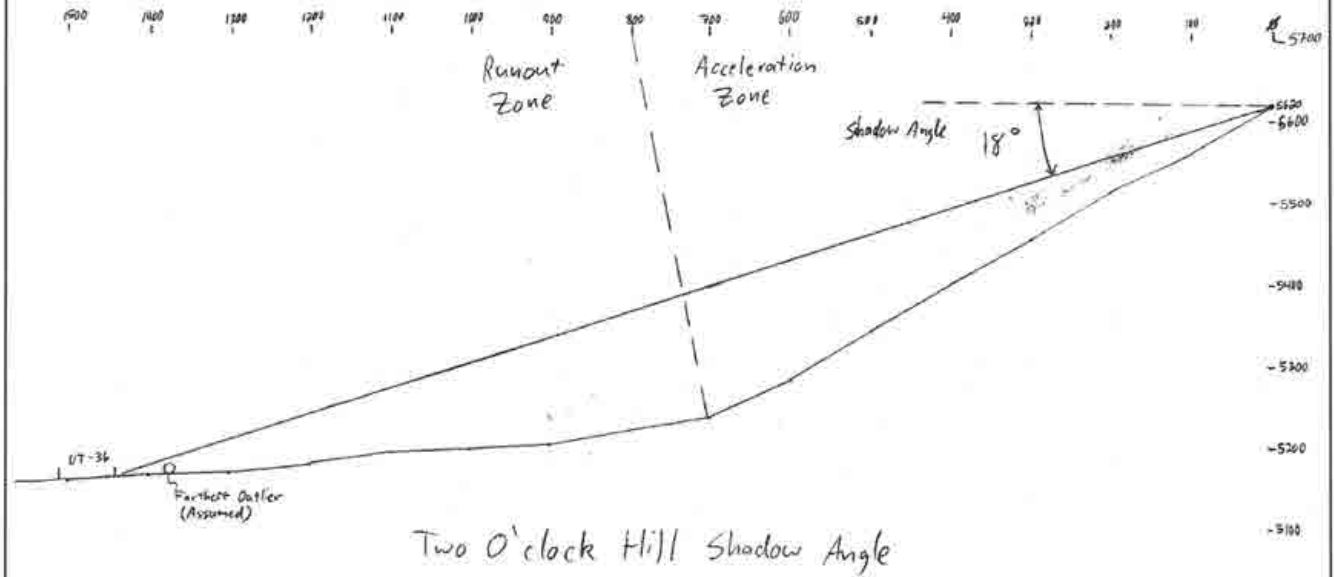
FIGURE NO.: 3a

SHADOW ANGLE DETERMINATION TWO O'CLOCK HILL ONE O'CLOCK HILL SETTLEMENT CANYON ROAD AND UT-36 TOOELE, UTAH
